**TETRA TECH, INC.****MEMORANDUM**

TO: Brenda Kerr, Plan Formulation, Alaska District Corps of Engineers
FROM: Bill Fullerton, Senior Hydraulic Engineer; Ridge Robinson, Program Manger
SUBJECT: **October 21, 2003 Matanuska River Trip**
DATE: November 10, 2003

Trip Report, Matanuska River Bank Erosion Inspection near Palmer, Alaska
October 21, 2003

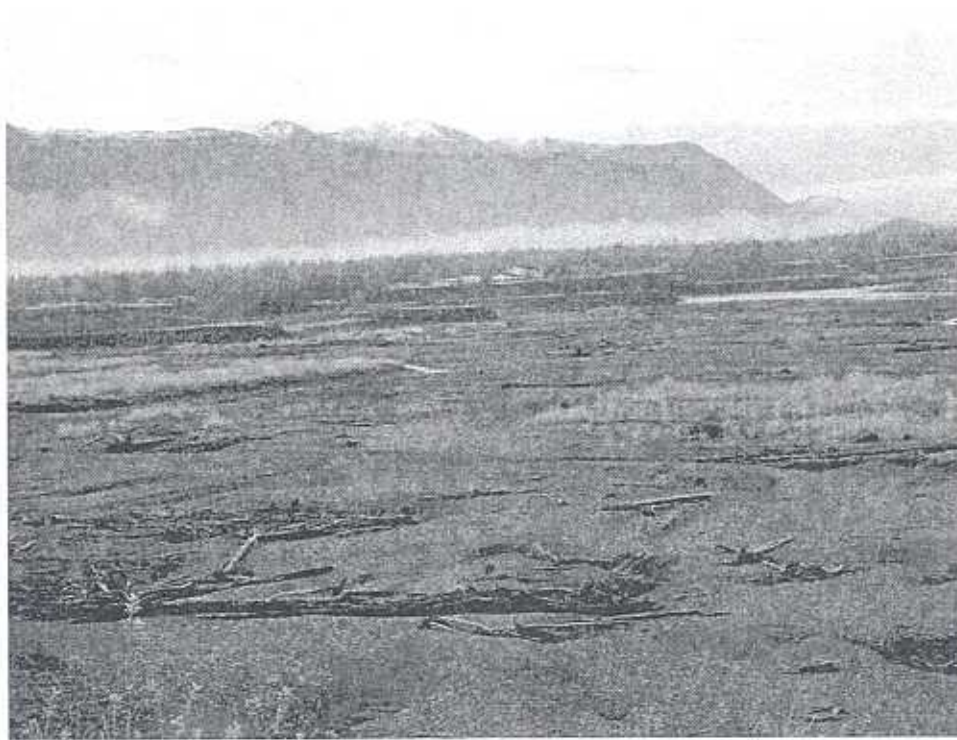
Photo 1 – Looking downstream toward the Circle View Estates Spur Dikes from Bodenburg Loop Road, all four spur dikes in the photo.

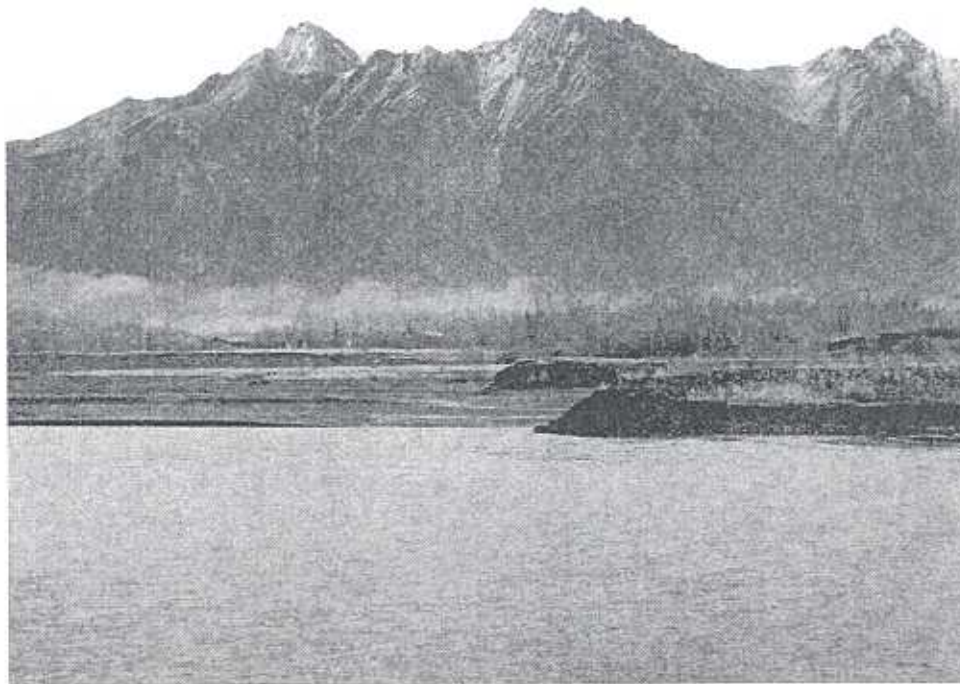
Inspection of the spur dikes indicated that all four had riprap eroded from the nose. This results in shortening of the dikes and also reduces the effectiveness of the dikes in deflecting the flow away from the banks. The Borough indicated that it is planning to repair the dikes and have funded on the order of \$50,000 for this purpose. In general, the Borough indicated that annual maintenance expenses for the spur dikes typically falls between \$50,000 and \$70,000 per year.

Photo 2 – View looking upstream at dike 3 from dike 4, flow impinges on nose and is partially deflected.

If the spur dikes are to remain effective in this area, then they need to be maintained to their original design configuration. This includes restoring their length and the rounded nose or bulb at the end of each dike. Based on conversations with the Borough representative, the cost of doing such maintenance has been expensive. This illustrates the difficulty and expense associated with trying to control a glacial fed braided river in a broad valley through placement of riprap.

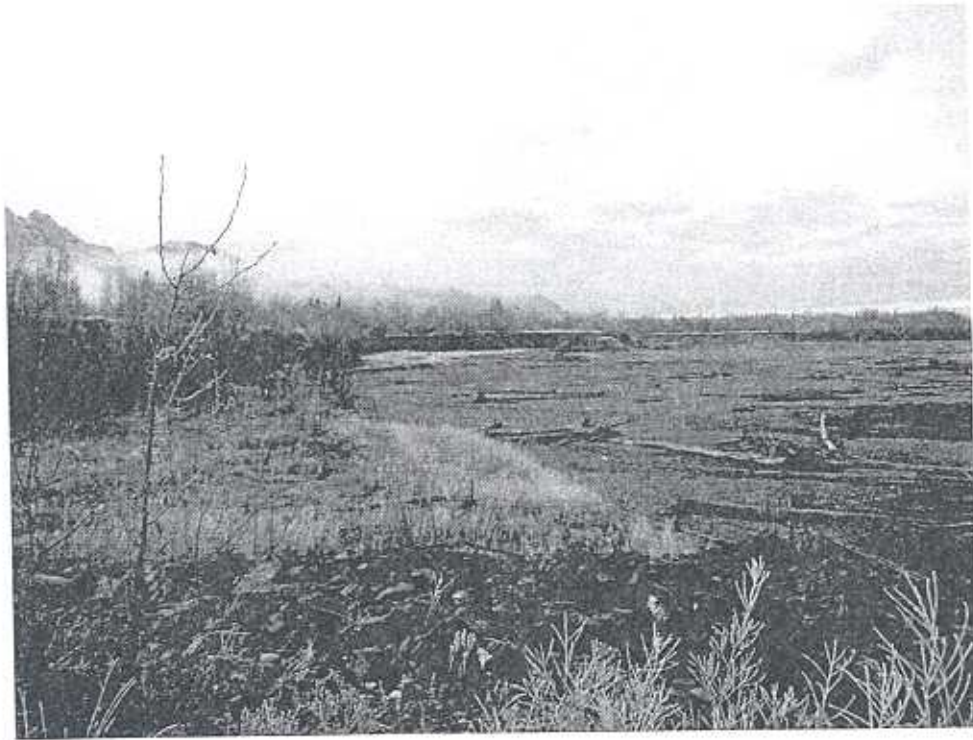
Photo 3 – Looking downstream from spur dike 4, flow is currently deflected away from bank, though dry river bed extends to bank approximately 400 feet downstream of the spur dike.

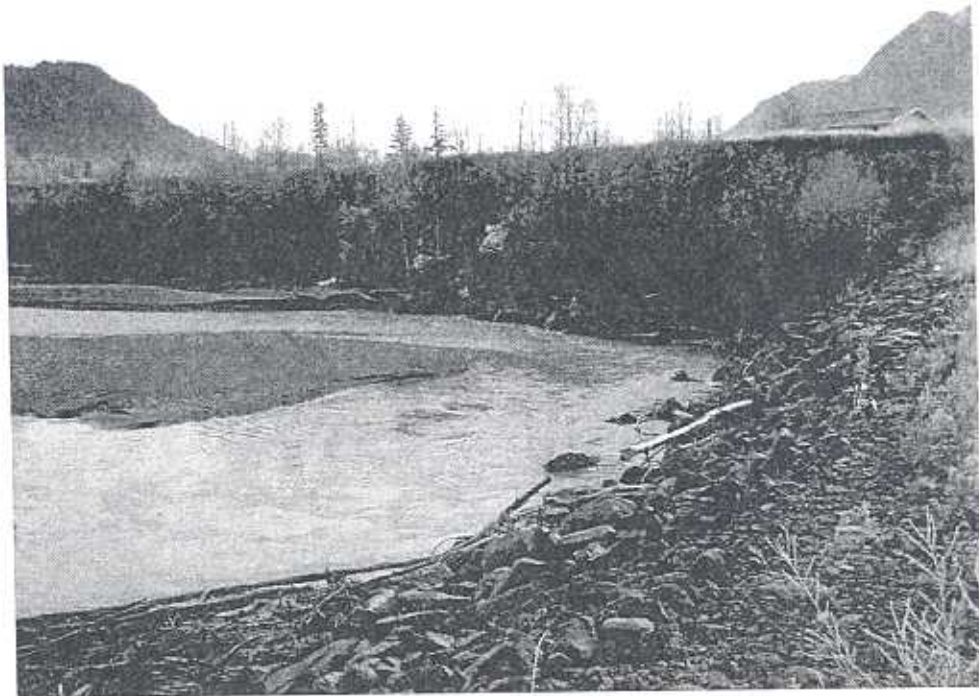
The current flow and deposition patterns in the area of the spur dikes are depicted in Photos 2 through 8. The current area of concern is between spur dikes 3 and 4, where the flow arcs between the dikes and

flows along the toe of the bank for a short distance (Photo 4). The flow was not impinging along the bank between any of the other spur dikes nor immediately upstream or downstream of the spur dikes. However, because of the braided, constantly shifting nature of the Matanuska River, the situation that currently exists between spur dikes 3 and 4 could exist between any of the other pair of dikes in the future and has likely existed in the past.

Based on the site visit, it appears that there is a potential for bank erosion to be initiated between spur dikes 3 and 4. This is a result of the combination of the present main channel alignment with spur dike 3 and the damage to the noses of spur dikes 3 and 4 (Note: Spur dikes 1 and 2 have experienced similar damage, and would be susceptible to similar conditions if the main channel would shift to their locations.). Because of this situation, maintenance is required on all four spur dikes if they are to continue to be effective in controlling bank erosion.

Photo 4 – View looking upstream from spur dike 4 at area where low flow impinges on bank between spur dikes 3 and 4

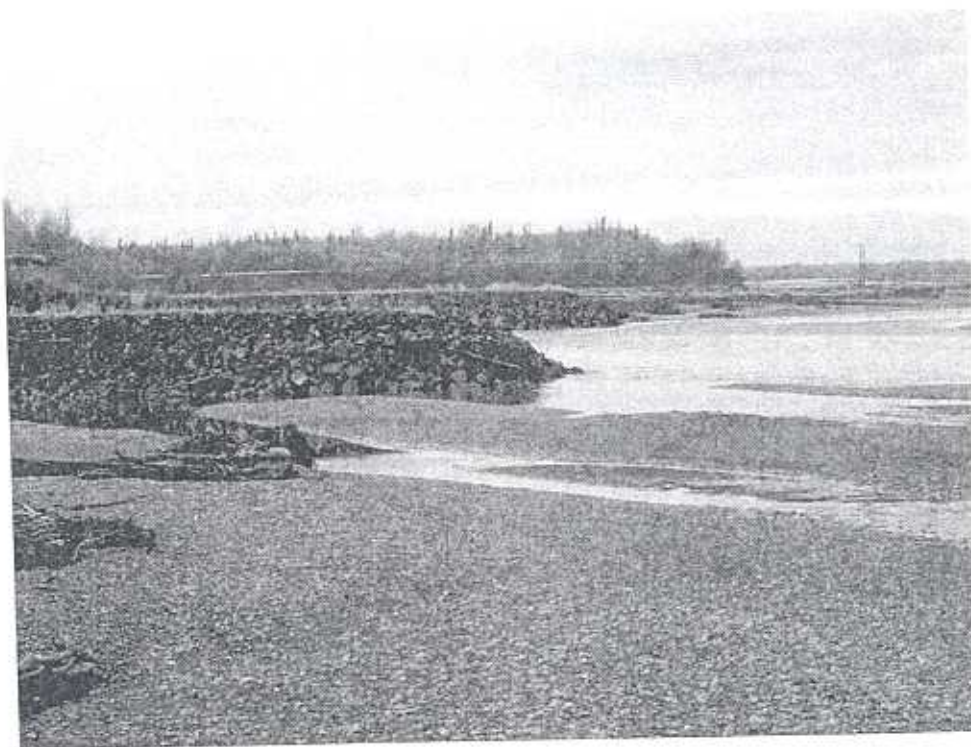
Photo 5 – Looking downstream from spur dike 2 at spur dikes 3 and 4.

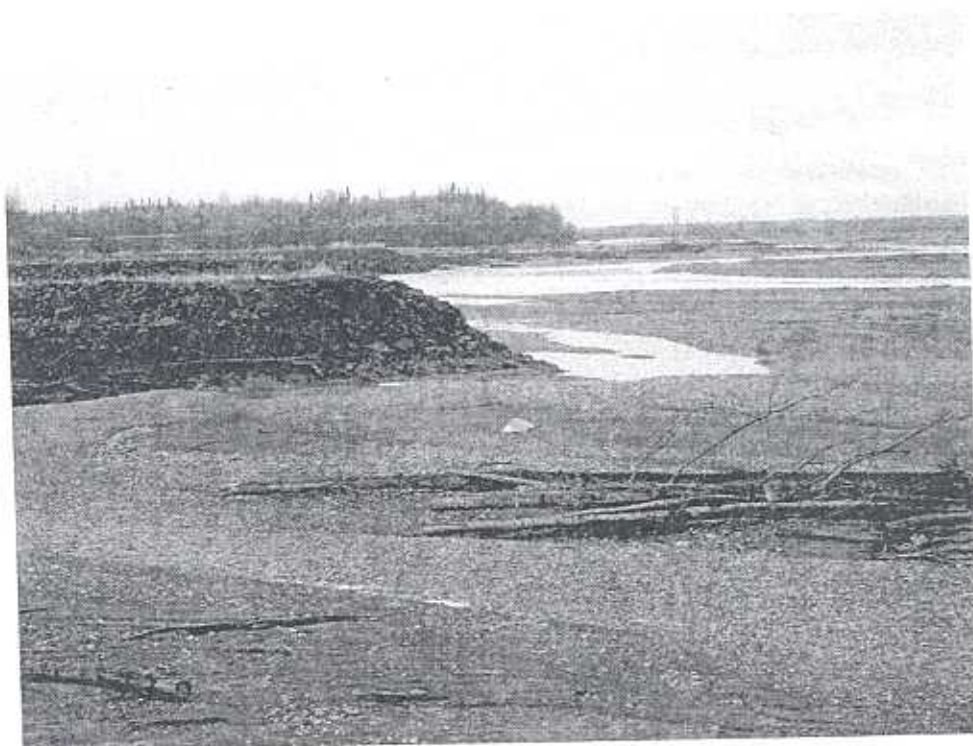
Photo 6 – Looking downstream at spur dike 2 from spur dike 1.

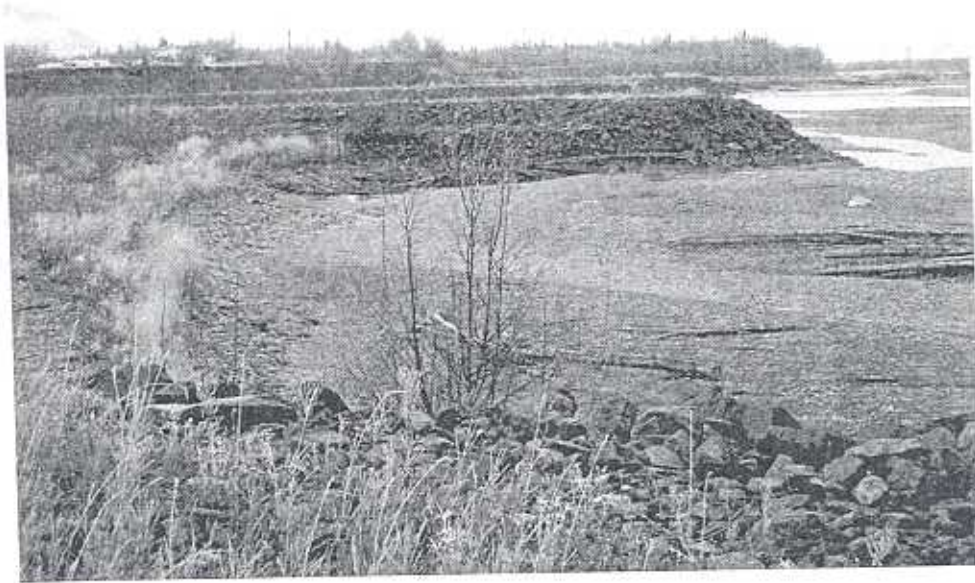
Photo 7 – Looking downstream at area between spur dikes 1 and 2 from spur dike 1, higher vegetated deposits indicate main flow has not recently reached the bank in this area

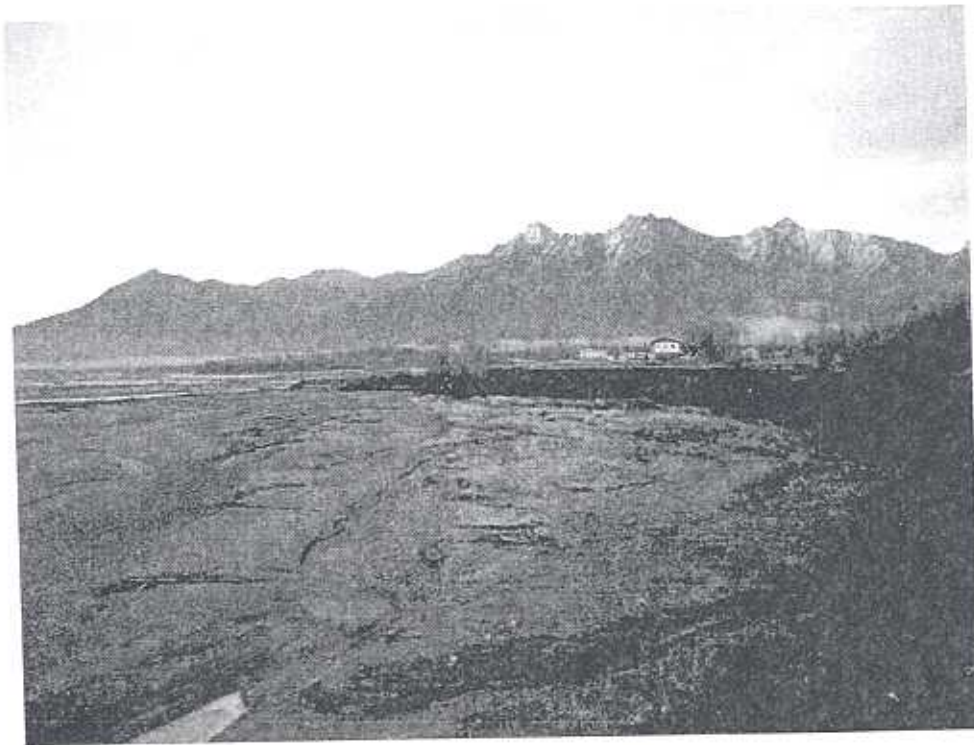
Photo 8 – View looking upstream from spur dike 1.

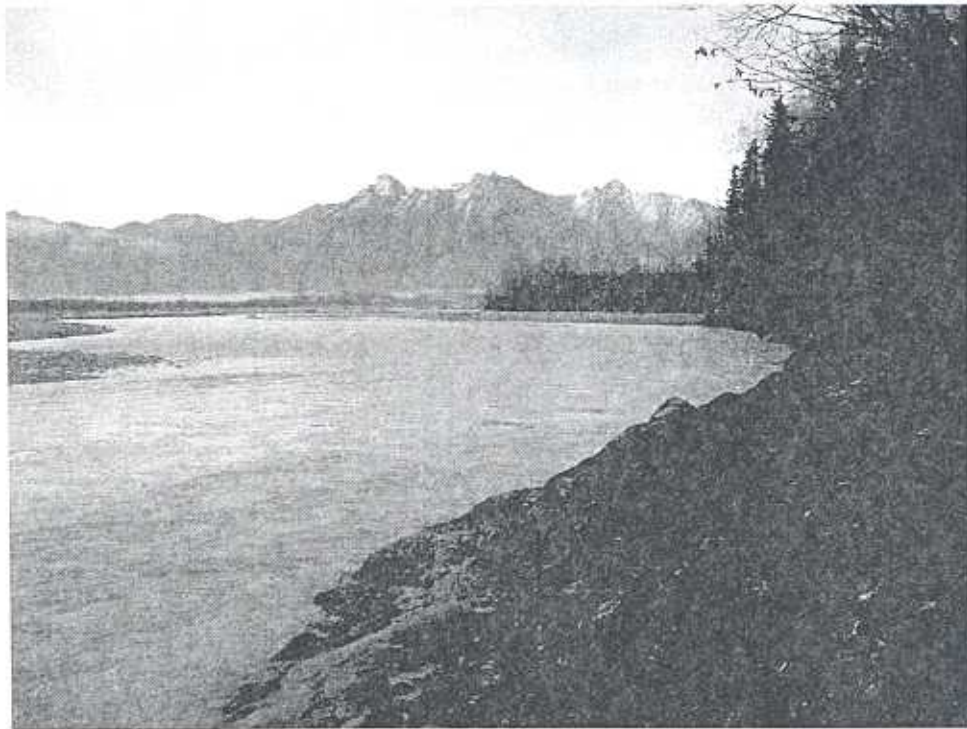
The areas of bedrock outcrops downstream of the spur dikes were inspected. Photo 9 shows the two primary outcrops.

Photo 9 – Looking upstream from downstream bedrock outcrop toward upstream bedrock outcrop below Circle View Estates.
