FLOOD PLAIN INFORMATION

TALKEETNA RIVER - SUSITNA RIVER - CHULITNA RIVER

TALKEETNA, ALASKA

PREPARED FOR THE MATANUSKA-SUSITNA BOROUGH BY THE DEPT. OF THE ARMY, ALASKA DISTRICT, CORPS OF ENGINEERS, ANCHORAGE, ALASKA.

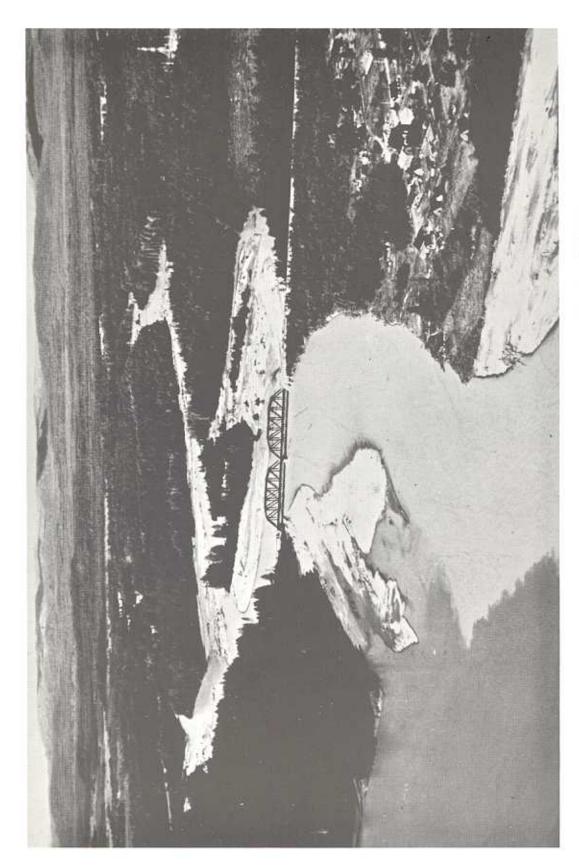
AERIAL VIEW OF TALKEETWA RIVER, LOOKING UPSTREAM, SHOWING NATURAL CONDITIONS OF THE RIVER IN AUGUST, 1949 FIGURE 2

In an effort to control erosion and protect its bridge, the Alaska Railroad, in 1949, made a channel change immediately upstream from the bridge. This realignment cut off a

meander of the river and allowed the river to flow at right angles to the bridge. Figures 2 and 3 illustrate the before and after conditions.

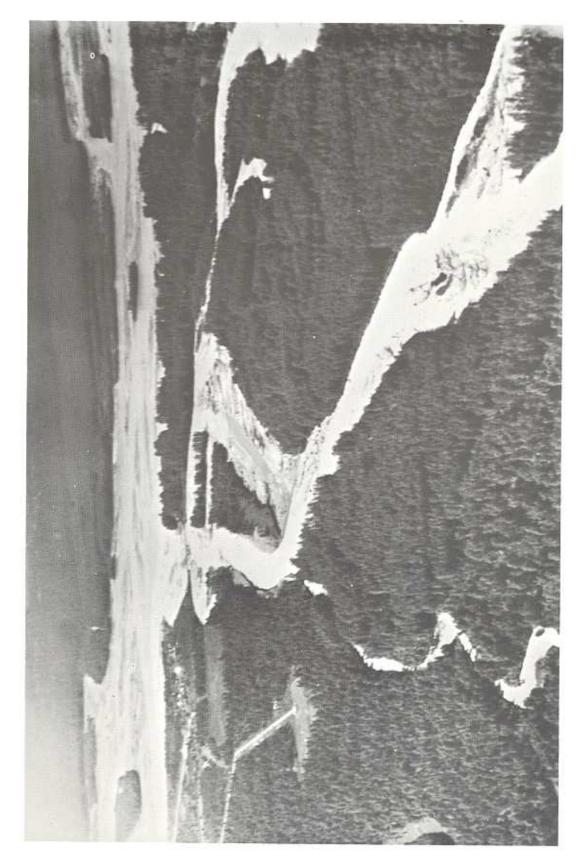
AERIAL VIEW OF TALKEETNA RIVER, AUGUST 1950, SHOWING THE CHANNEL CHANGE CONSTRUCTED BY THE ALASKA RAILROAD FIGURE 3

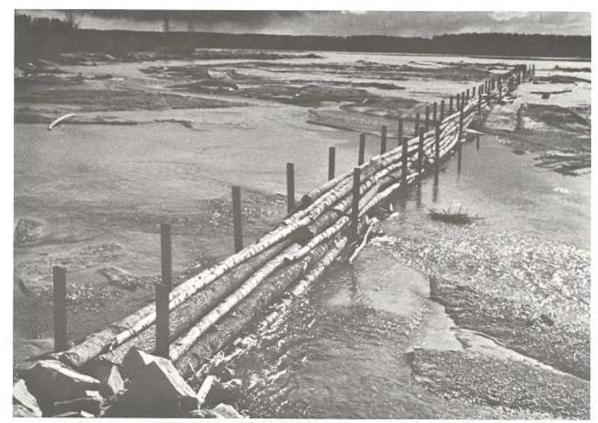
VIEW OF FASCINE FROM UPSTREAM END AS IT APPEARED IN MAY, 1951 FIGURE 4

Flood Damage Reduction Measures - In 1951 the Corps of Engineers completed an emergency bank protection project at Talkeetna, Alaska, under Section 14 of the 1946 Flood Control Act. The project, located on the left bank of the Talkeetna River below the Alaska Railroad Bridge, consists of a brush and timber fascine 1,000 feet long which was constructed to arrest erosion. Subsequent to construction of the emergency work, a flood control project was authorized which called for a stone revetment approximately 1,500 feet long downstream from the railroad bridge. In 1960 this authorized project was placed in an inactive category as the emergency timber fascine constructed in 1951 was performing satisfactorily. Recently, the river has cut a small channel through the fascine structure and the village is again threatened by erosion. A restudy by the Corps of Engineers of the authorized project to determine feasibility, justification and local cooperation requirements under existing conditions in the area will probably be undertaken in Fiscal Year 1973.

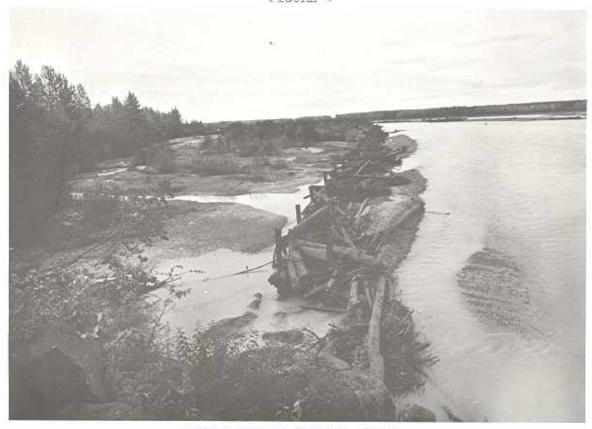
FASCINE AS IT APPEARS TODAY FIGURE 5

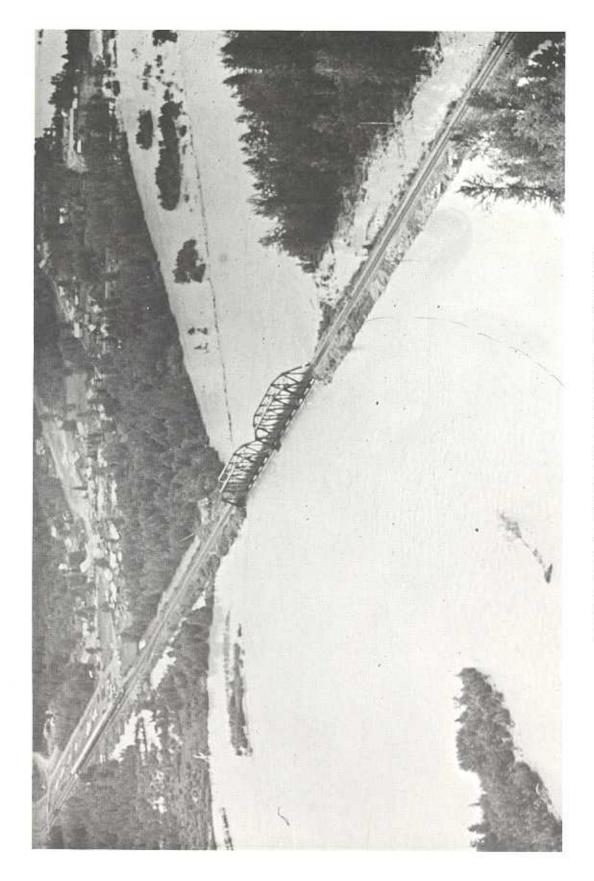
AERIAL VIEW OF THE AUGUST 1971 FLOOD AT TALKEETINA FIGURE 6

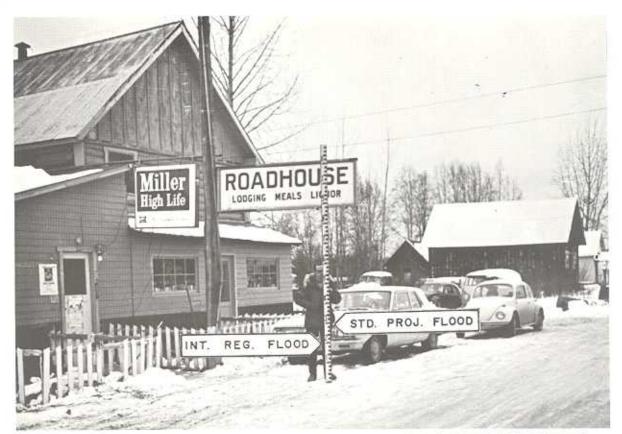
FUTURE FLOOD HEIGHTS AT THE ROADHOUSE ON THE MAIN STREET OF TALKEETNA FIGURE 7

Photographs, Future Flood Heights - The levels that the Intermediate Regional and Standard Project Floods are expected to reach at various locations in the village of Talkeetna are indicated on the following photographs.

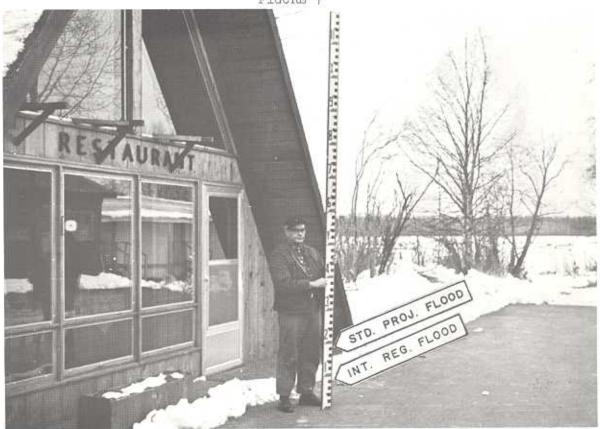
FUTURE FLOOD HEIGHTS AT THE TALKEETNA MOTEL AND RESTAURANT FIGURE 8

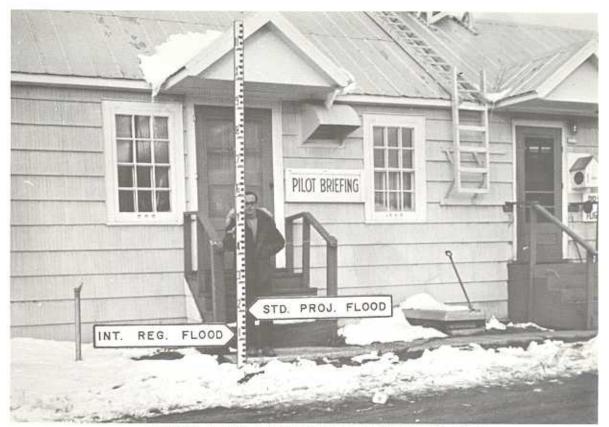
FUTURE FLOOD HEIGHTS AT THE TALKEETNA FSS FIGURE 9

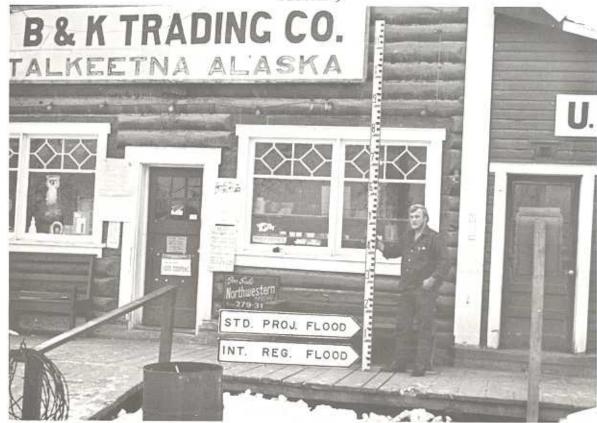
FUTURE FLOOD HEIGHTS AT THE B & K TRADING CO. - MAIN STREET, TALKEETNA.
U. S. POST OFFICE TO THE RIGHT
FIGURE 10

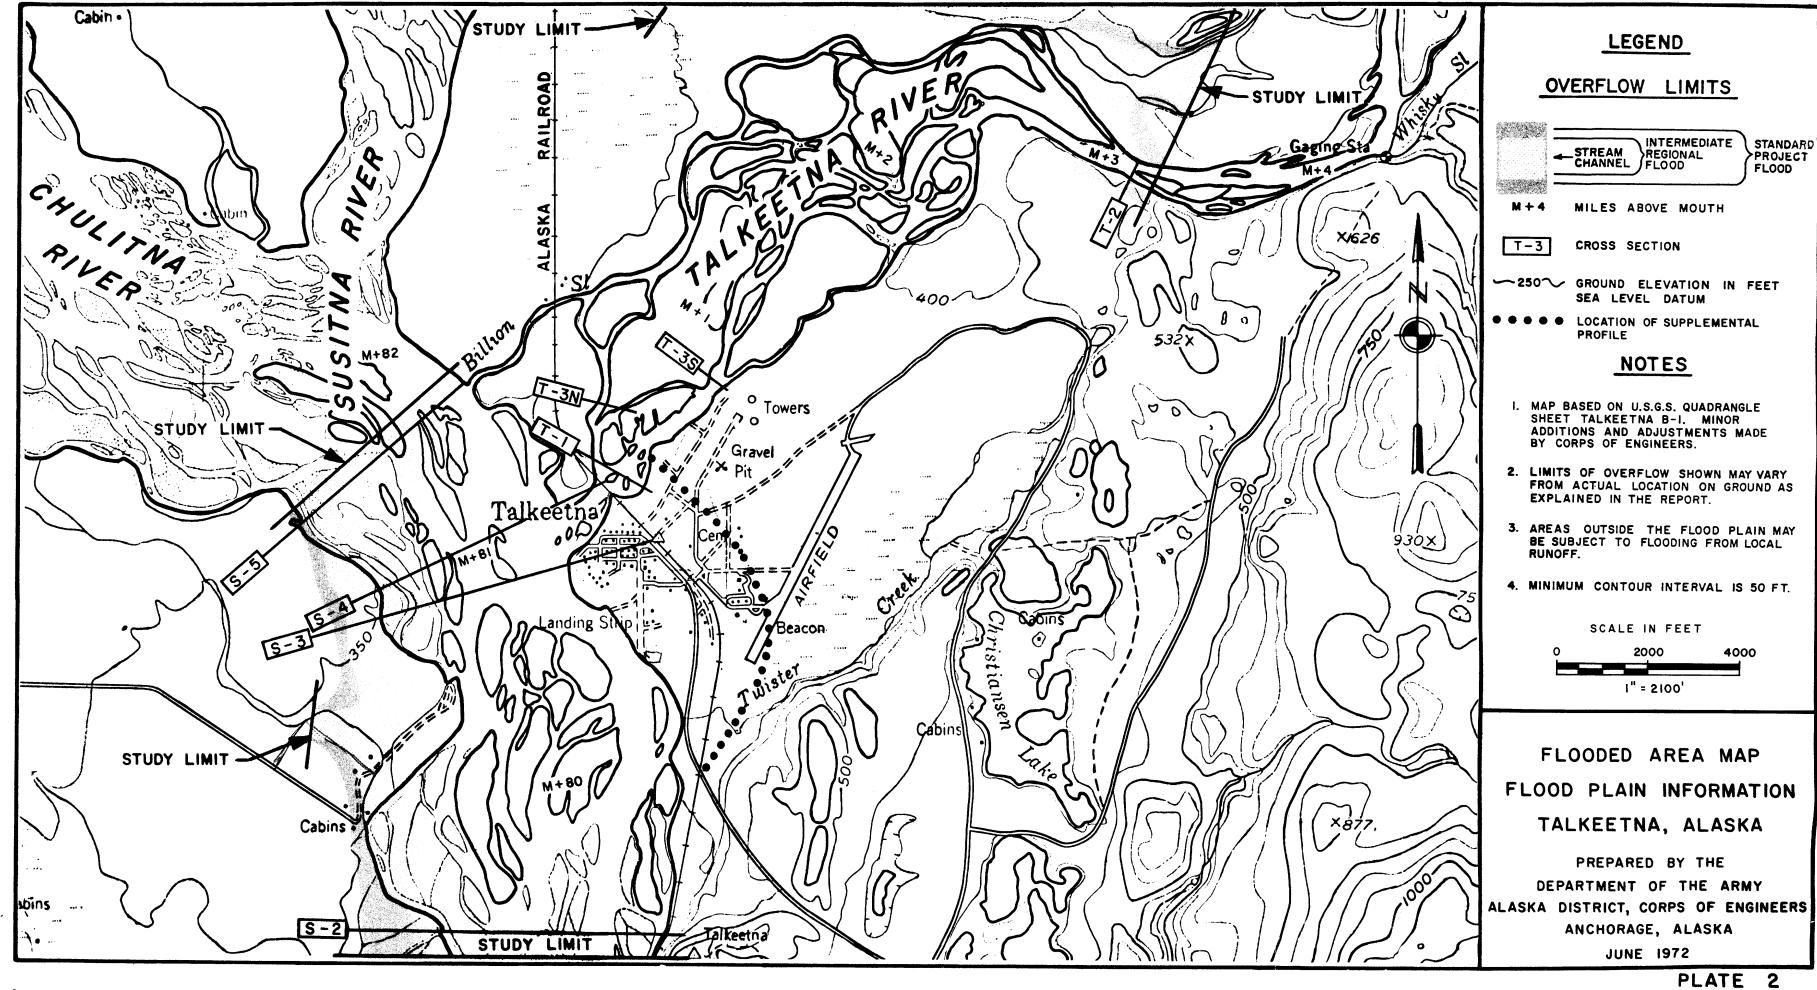
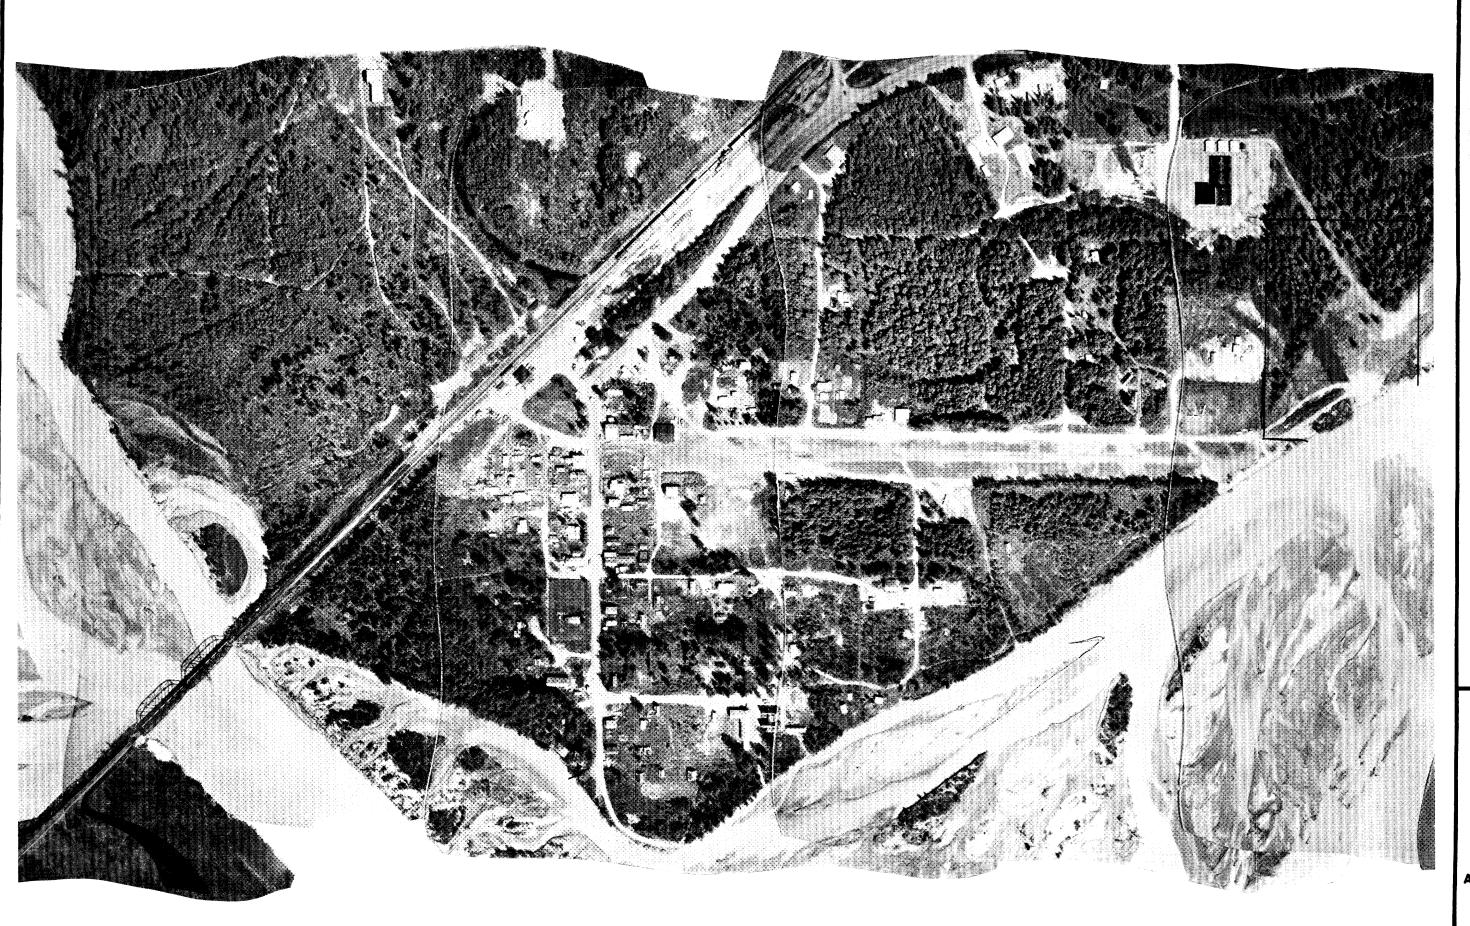
FLOODED AREA MAP
FLOOD PLAIN INFORMATION
TALKEETNA, ALASKA

OVERFLOW LIMITS

Flooded Areas and Flood Damages - The areas in the village of Talkeetna that are subject to flooding by the Intermediate Regional and Standard Project Floods are shown on Plates 2 and 3. The actual limits of these overflow areas may vary somewhat from those shown on the maps because the 50 foot contour interval and scale of the maps do not permit precise plotting of the flooded area boundaries. As may be seen from these plates, floodflows from the Susitna and Talkeetna Rivers cover essentially all of the village. The highest stages of flooding throughout the study area occur when the floodwaters from the Talkeetna meet with the high stages of the Susitna River. Areas that will be flooded by the Intermediate Regional or Standard Project Floods include commercial and residential sections along with the associated roads and private utilities. Considerable damage to these facilities would occur during an Intermediate Regional Flood. The majority of homes in Talkeetna would be damaged by this flood. Heavily laden flood waters would deposit their silt load throughout the village due to the lower velocities of overbank flow in this area. Utilities and transportation facilities would be damaged in addition to an interruption of communications. Most of the water wells are not completely sealed, therefore the flooding and subsequent
