**MATANUSKA-SUSITNA BOROUGH
BOARD OF EQUALIZATION
AGENDA
AUDIO CONFERENCE IN MICROSOFT TEAMS
MAY 5, 2020 9:00 AM**

APPEAL 121 - 56180000T039

APPEAL 009 - 57473B03L007

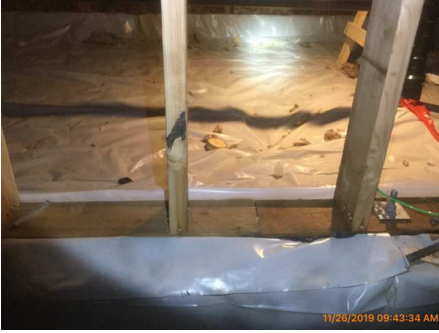
R Additional foundation bolting is needed. Sill plates should be provided with proper bolting into the footings within 12" of the end of a sill plate as well as typically every 36-48".

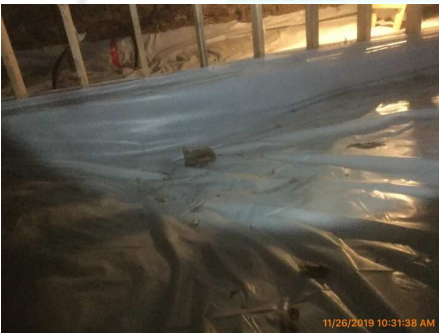
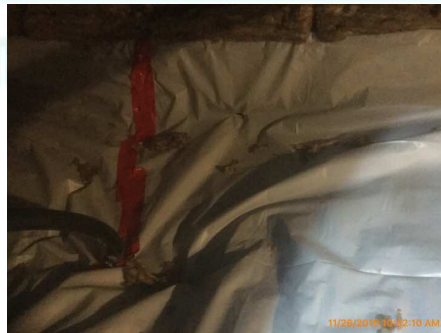
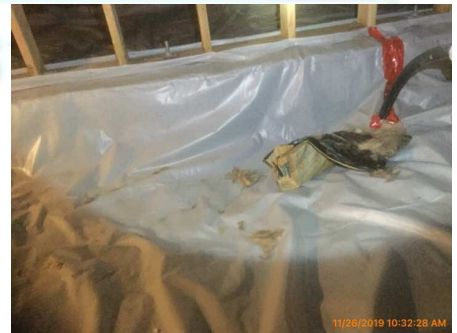
R Minor settlement has occurred at the exterior footing near the water line. This area should be in-filled with clean gravel to properly support the footing above. No evidence of damage to the footing was visible at the time of inspection.

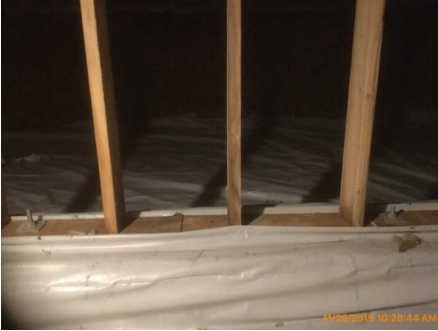
R Additional foundation bolting is needed. Sill plates should be provided with proper bolting into the footings within 12" of the end of a sill plate as well as typically every 36-48".

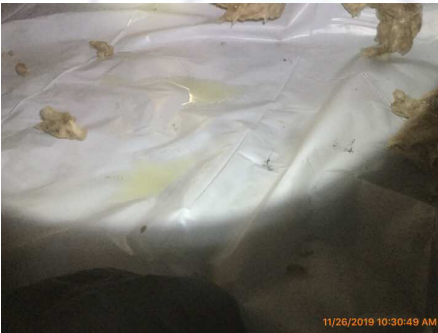
R Standing water was observed in the crawl space under the kitchen. The source of the water was not located. Wet crawl spaces risk building damage from rot and insects and can cause interior mold or mildew. Roof and lot drainage repairs or improvements should be addressed as a first step to controlling water in the crawl space (see "Exterior"). This condition should then be monitored to determine if additional, potentially costly measures are necessary.

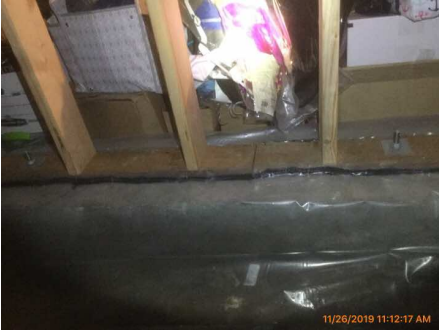
R Additional foundation bolting is needed. Sill plates should be provided with proper bolting into the footings within 12" of the end of a sill plate as well as typically every 36-48".

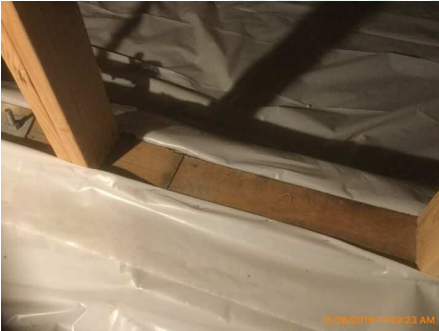
CRAWL SPACE

R Additional foundation bolting is needed. Sill plates should be provided with proper bolting into the footings within 12" of the end of a sill plate as well as typically every 36-48".

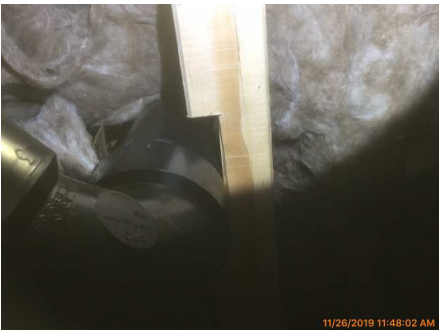
R A floor joist is notched and or cut at the toilet. This weakens the joist and risks structural damage; repairs or additional support are needed.

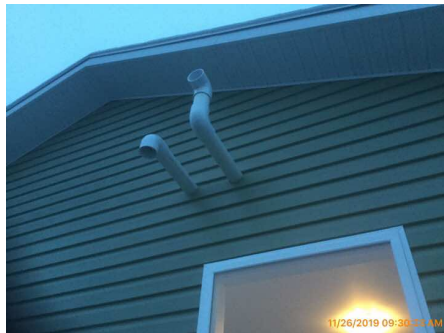
R Openings were noted in the siding at the gas line, communications cabling and boiler flue penetrations. All penetrations in the siding should be well sealed to prevent moisture and insect intrusion.

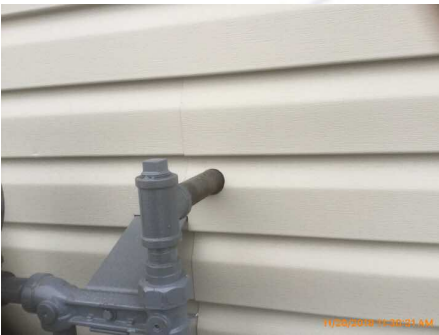
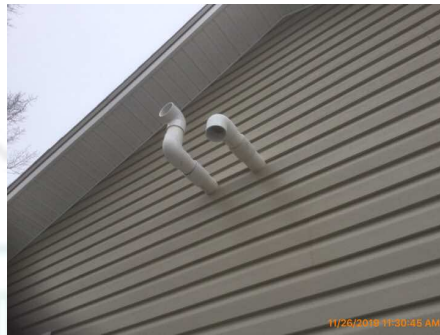
R Openings were noted in the siding at the gas line, communications cabling and boiler flue penetrations. All penetrations in the siding should be well sealed to prevent moisture and insect intrusion.

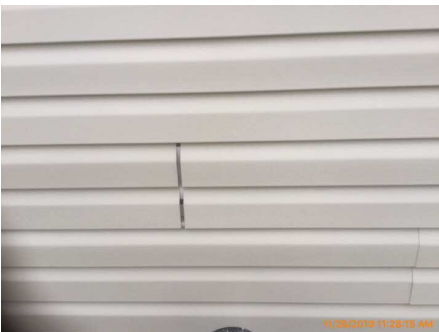
R Siding is incomplete at the left side of the building. This should be corrected prior to moisture intrusion.

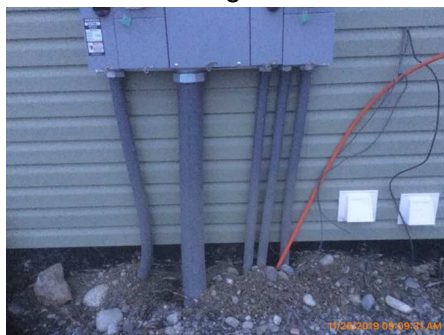
R The electrical service mast / conduits are required to be fully secured to the exterior of the home. This should be investigated and corrected as needed by a licensed electrical contractor.

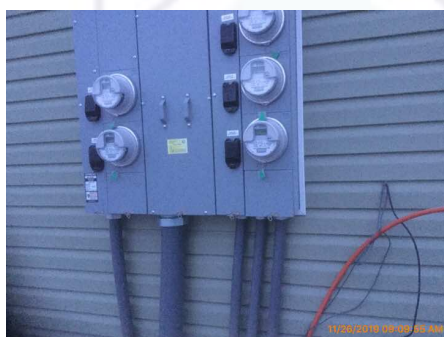
SI A grounding buss is currently required to be provided at the exterior of the meter base for use by the other utilities. This should be corrected.

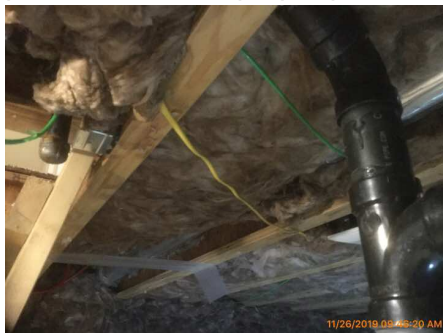
SI Romex cabling is installed below the bottom level of the floor joists in the crawlspace. This is not permitted without proper protections. This should be corrected as needed.

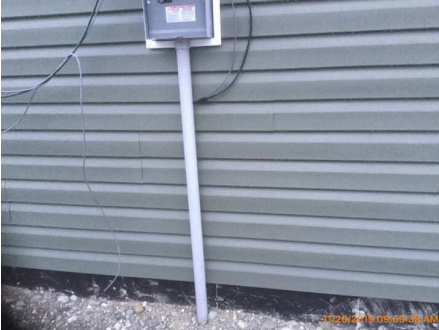
R The electrical service mast / conduit is required to be fully secured to the exterior of the home. This should be investigated and corrected as needed by a licensed electrical contractor.

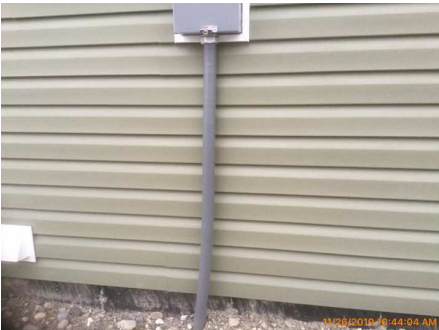
R The electrical service mast / conduit is required to be fully secured to the exterior of the home. This should be investigated and corrected as needed by a licensed electrical contractor.

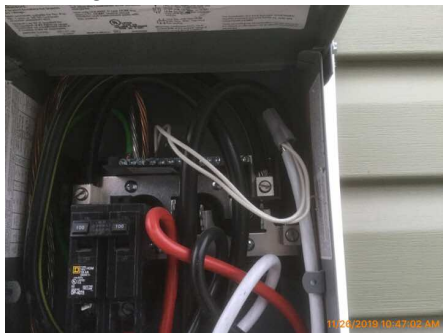
SI The house neutral wire is pigtailed onto the neutral buss. The wires are undersized and this should be investigated and corrected as needed by a licensed electrical contractor.

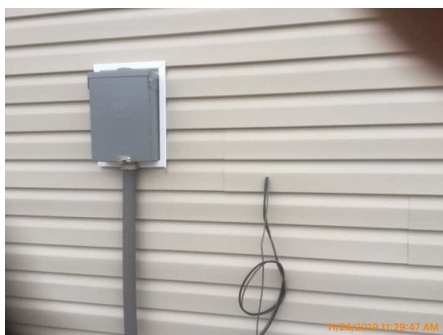
SI A grounding buss is currently required to be provided at the exterior of the meter base for use by the other utilities. This should be corrected.

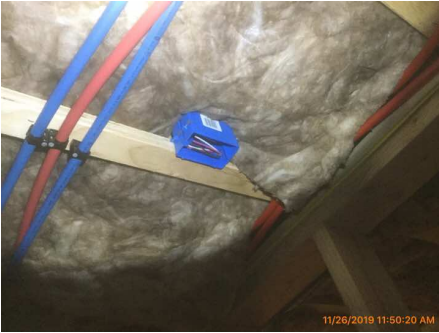
SI Loose or missing junction box cover plates were noted in the crawlspace. All junction boxes should be fitted with cover plates, in order to protect the wire connections. All wires should be properly terminated.

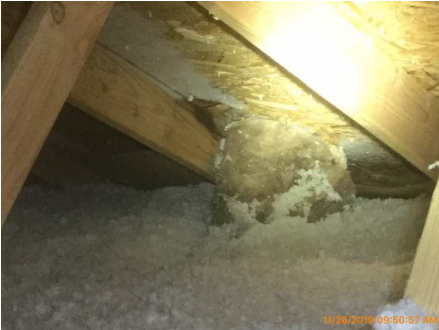
R Evidence of condensation and mildew was observed at the bathroom venting in the attic. This condition is usually the result of a poorly sealed vent termination. The sealing of the ducting to the roof jack should be improved with approved sealants or tapes. DUCT tape is not an approved sealant. If ignored, this situation could worsen and cause substantial degradation and rot.

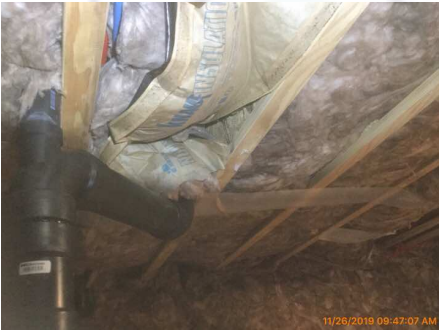
SI Some of the installed insulation in the crawlspace is craft faced and the facing is exposed. The manufacturer's documentation requires the facing to be covered as it is flammable. This should be corrected. A simple solution is to remove the paper facing or reverse the installation.

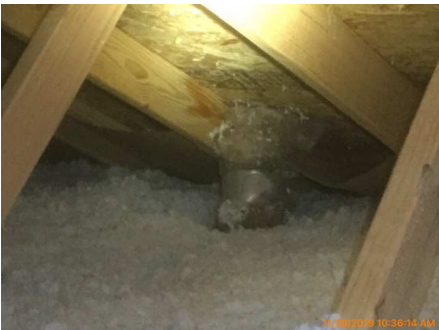
R Evidence of condensation and mildew was observed at the bathroom venting in the attic. This condition is usually the result of a poorly sealed vent termination. The sealing of the ducting to the roof jack should be improved with approved sealants or tapes. DUCT tape is not an approved sealant. If ignored, this situation could worsen and cause substantial degradation and rot.

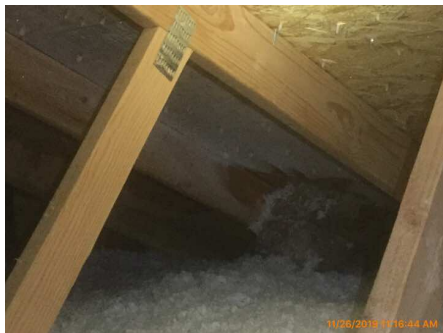
R Evidence of condensation and mildew was observed at the bathroom venting in the attic. This condition is usually the result of a poorly sealed vent termination. The sealing of the ducting to the roof jack should be improved with approved sealants or tapes. DUCT tape is not an approved sealant. If ignored, this situation could worsen and cause substantial degradation and rot.

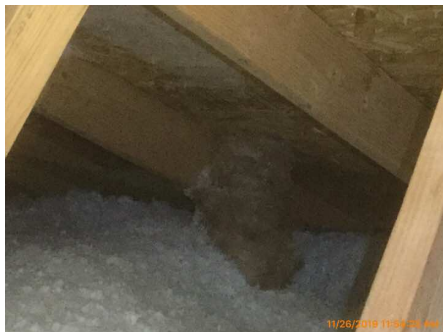
R Evidence of condensation and mildew was observed at the bathroom venting in the attic. This condition is usually the result of a poorly sealed vent termination. The sealing of the ducting to the roof jack should be improved with approved sealants or tapes. DUCT tape is not an approved sealant. If ignored, this situation could worsen and cause substantial degradation and rot.

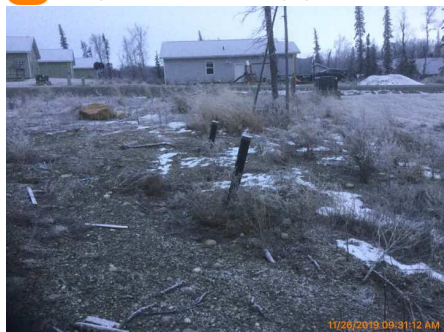
R Septic tank riser pipes are leaning in the yard. They should be corrected as needed.

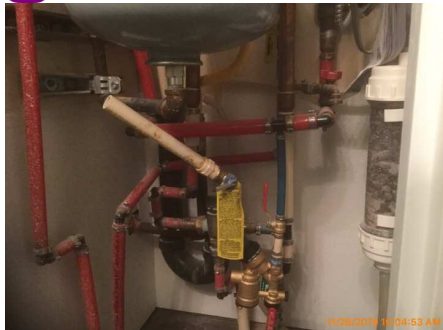
SI The pressure relief valve for the water heater is poorly directed. This should be corrected as needed.

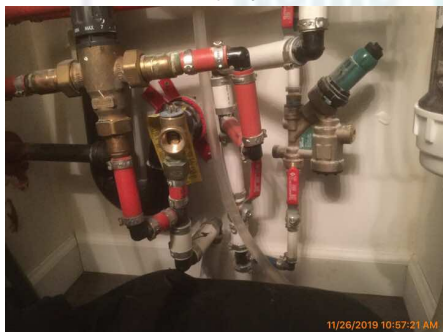
SI The discharge piping serving the Temperature and Pressure Relief (TPR) Valve for the water heater is missing and should terminate not less than 24" and no closer than than 6 inches above the floor. Should the TPR vent hot water and steam onto the platform it will make turning the gas valve off hazardous, and could result in injury.

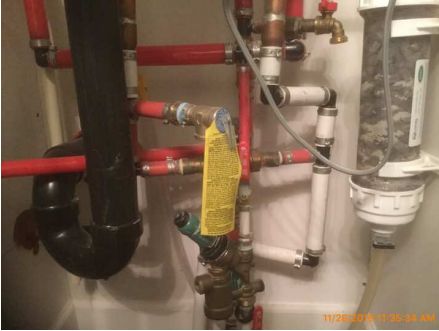
SI The discharge piping serving the Temperature and Pressure Relief (TPR) Valve for the water heater is missing and should terminate not less than 24" and no closer than than 6 inches above the floor. Should the TPR vent hot water and steam onto the platform it will make turning the gas valve off hazardous, and could result in injury.

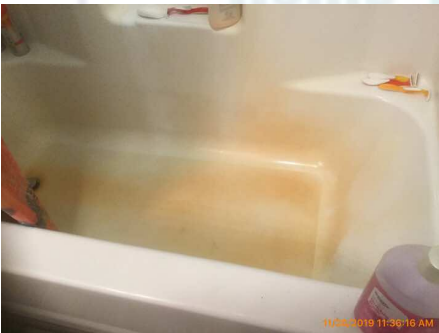
R The water in the home appears to have an color. Iron staining was noted in the bathtub. Additional treatment or filtration may be needed. Consultation with a water treatment professional is advised for the repair options available.
