**Subject:** Matanuska River Erosion Project – Matanuska Survey Data Summary

# MATANUSKA RIVER EROSION ASSESSMENT

## Design Study Report – Final

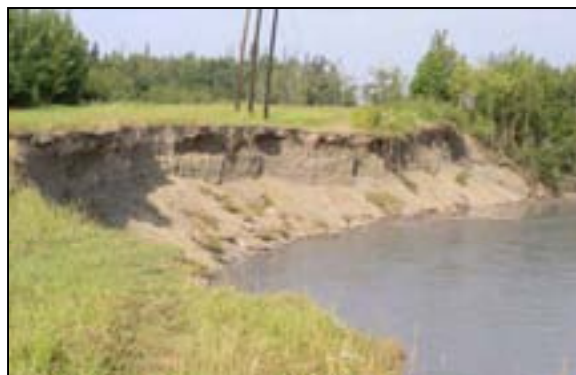
**Bank erosion near a powerline.**

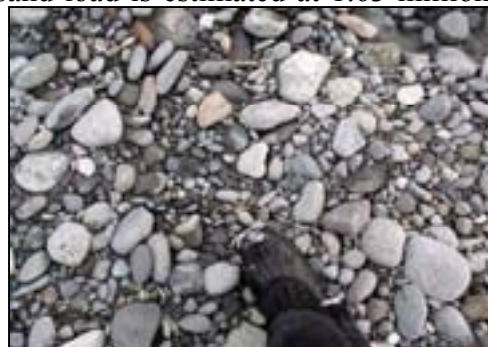
**Bed load material**

**Bed Load.** Bed load of the Matanuska River is approximately 7 percent of the total sediment load; therefore, the chance for local deposition to trigger avulsions (changes in channel direction and form) is also

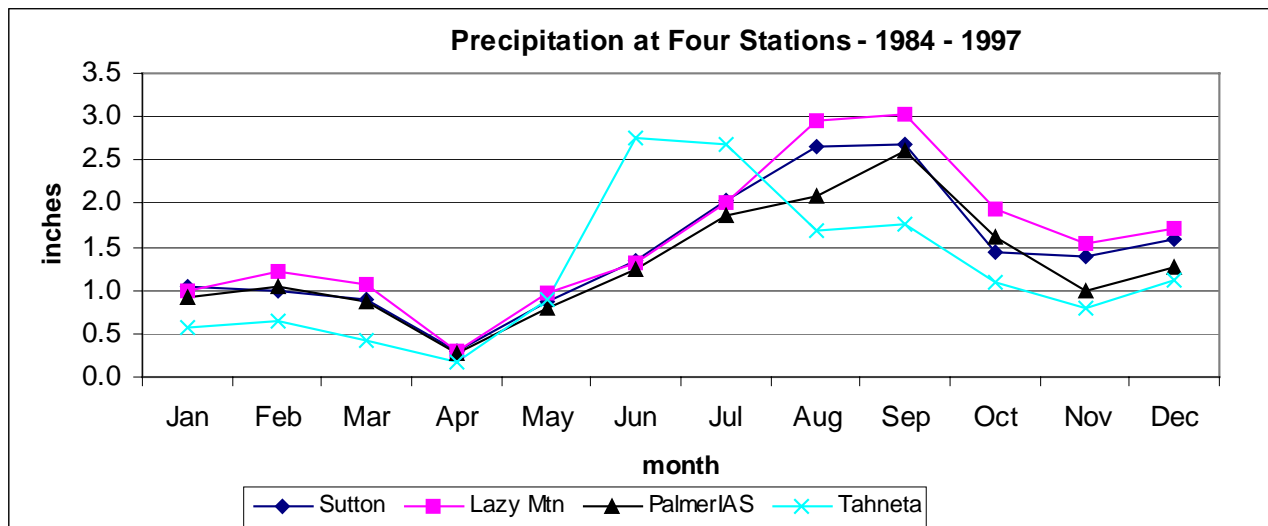
**Figure 7 Monthly Precipitation at Four Stations in the Matanuska Valley**

The timing of the peak annual rainfall at higher elevations may be shifted to earlier in the years, as suggested by the Tahnetta Pass gauge. No trends in precipitation were detected for any of the four stations over their discrete periods of record.

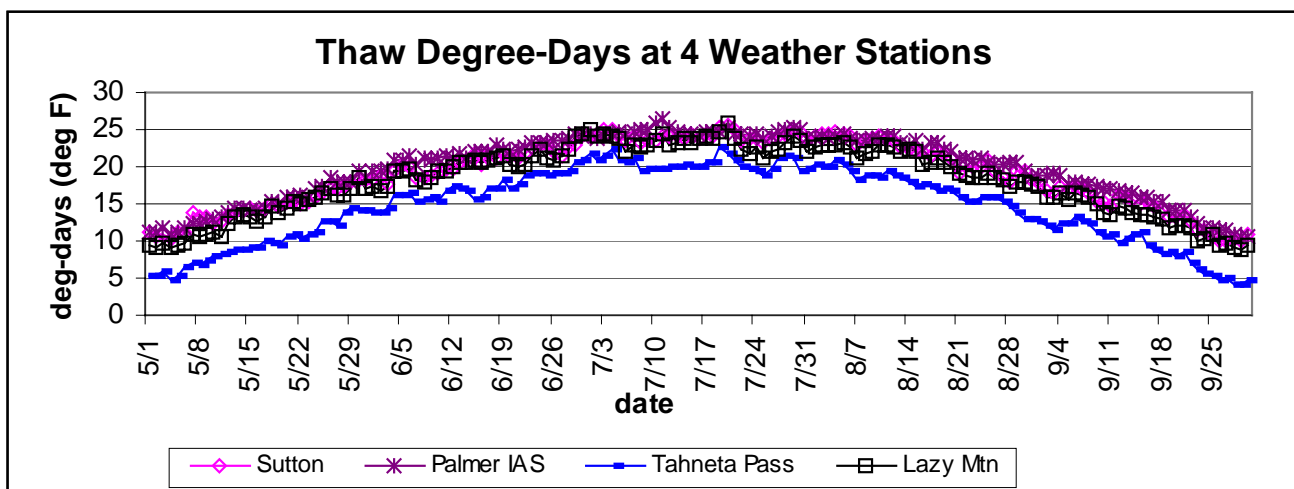
**Figure 8 Seasonal Thaw-degree days**

Since streamflow in the Matanuska River is affected by glacier melt, temperature and thaw-degree days at the four weather stations were evaluated. Degree-days above 32 were computed for May through September of each year at each station for which data temperature data were available. In order to achieve data sets of adequate length, temperature data was estimated if only one or two consecutive days' data were missing. Seasonal thaw-degree days for the four stations are shown in Figure 8.

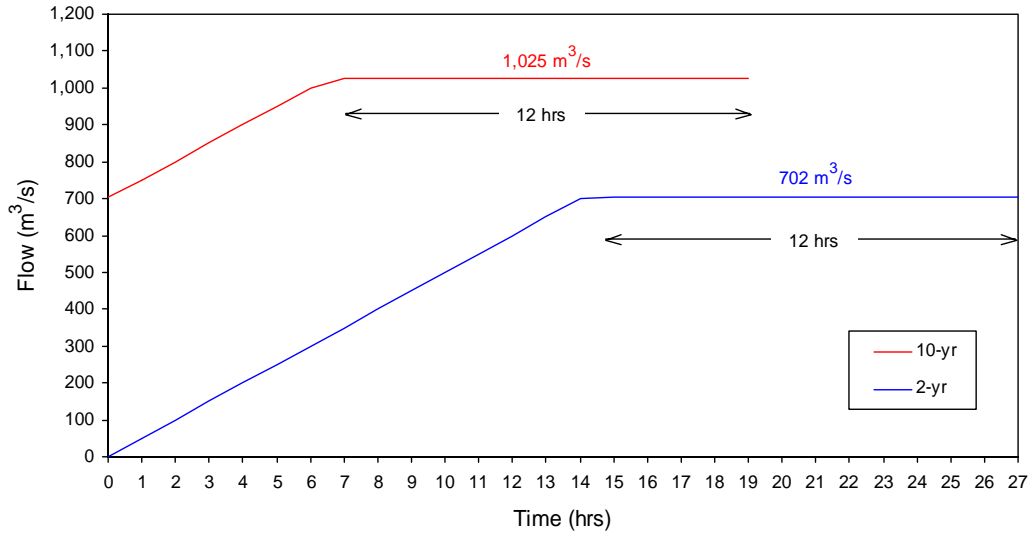
**Figure 6. Inflow hydrographs.**

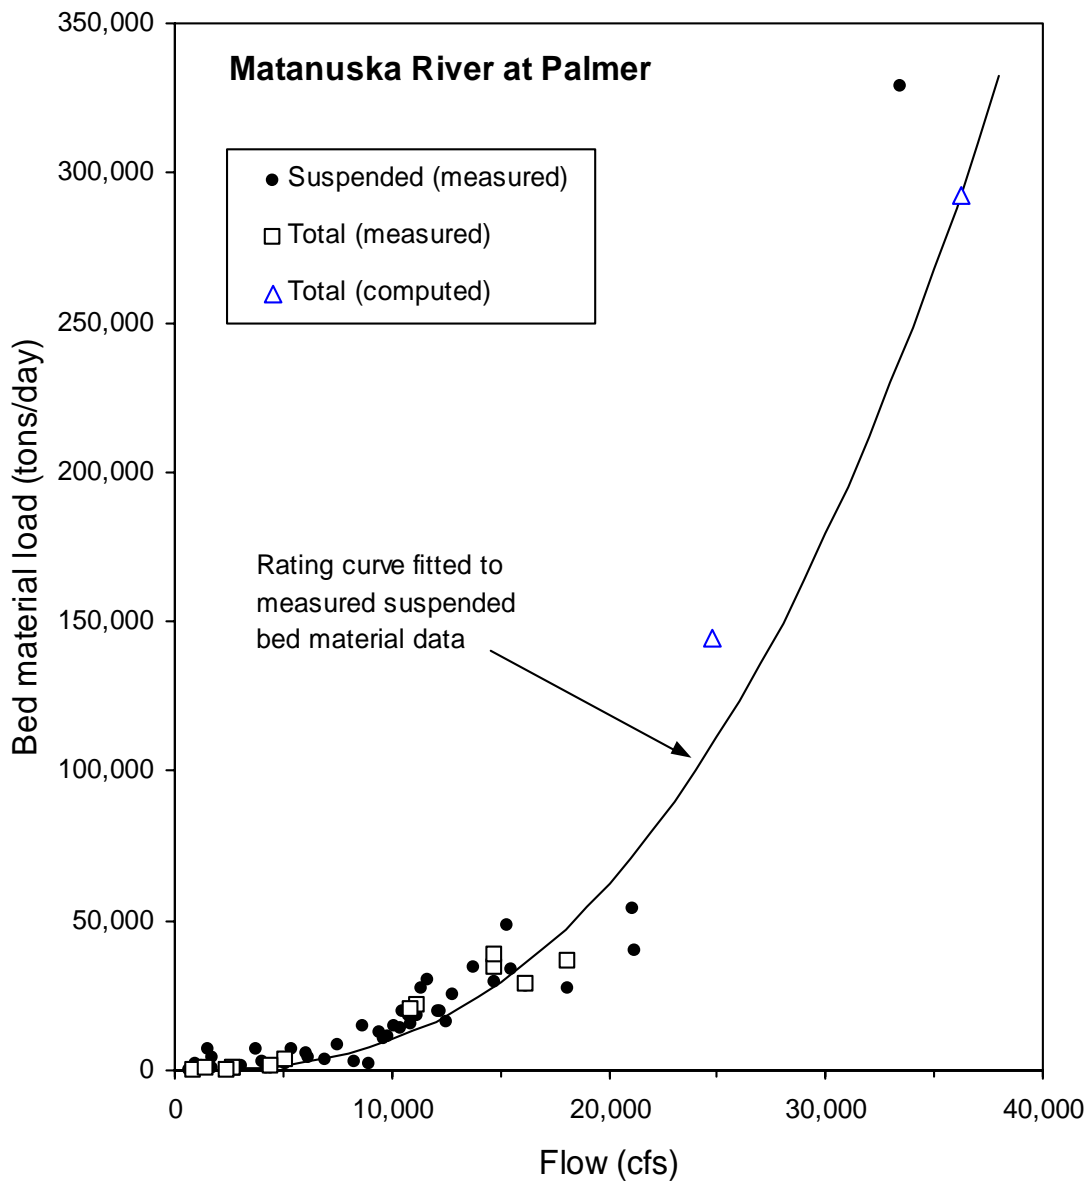
**Figure 25. Comparison of measured and computed sediment fluxes in Matanuska River at Palmer (gorge reach).**

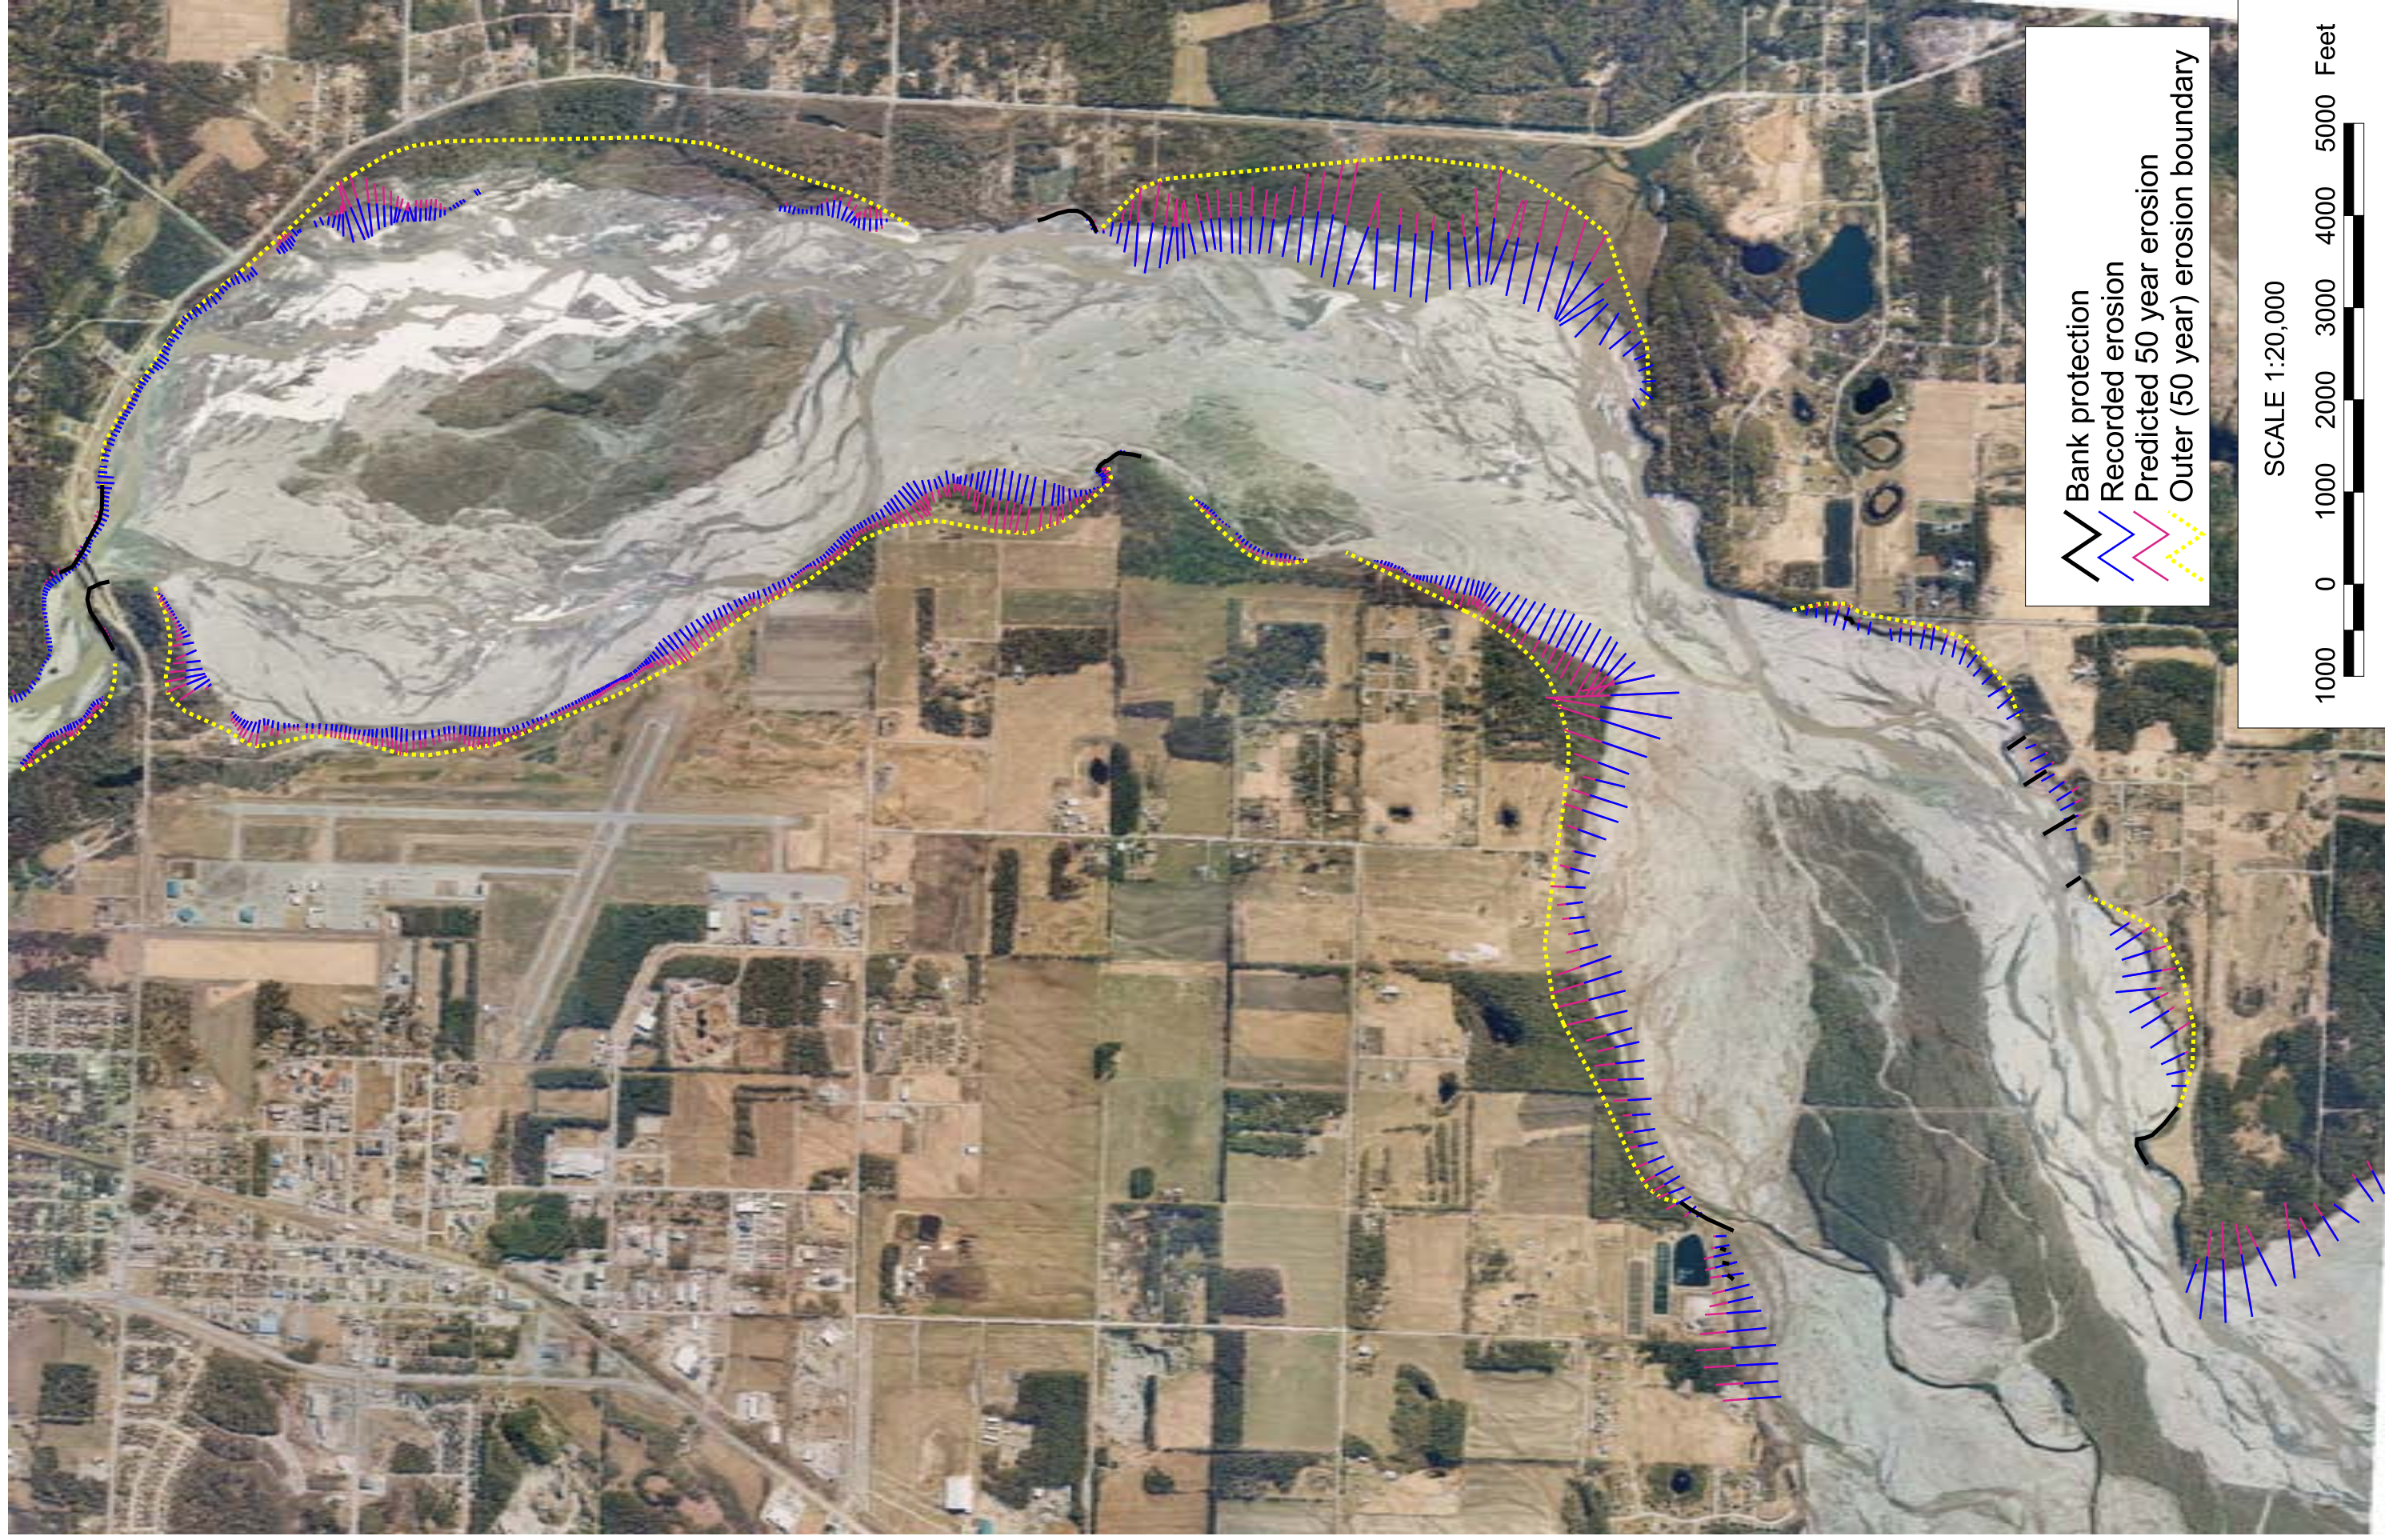
**FIGURE 6**  
Matanuska River:  
shaded relief map from 2003 LiDAR

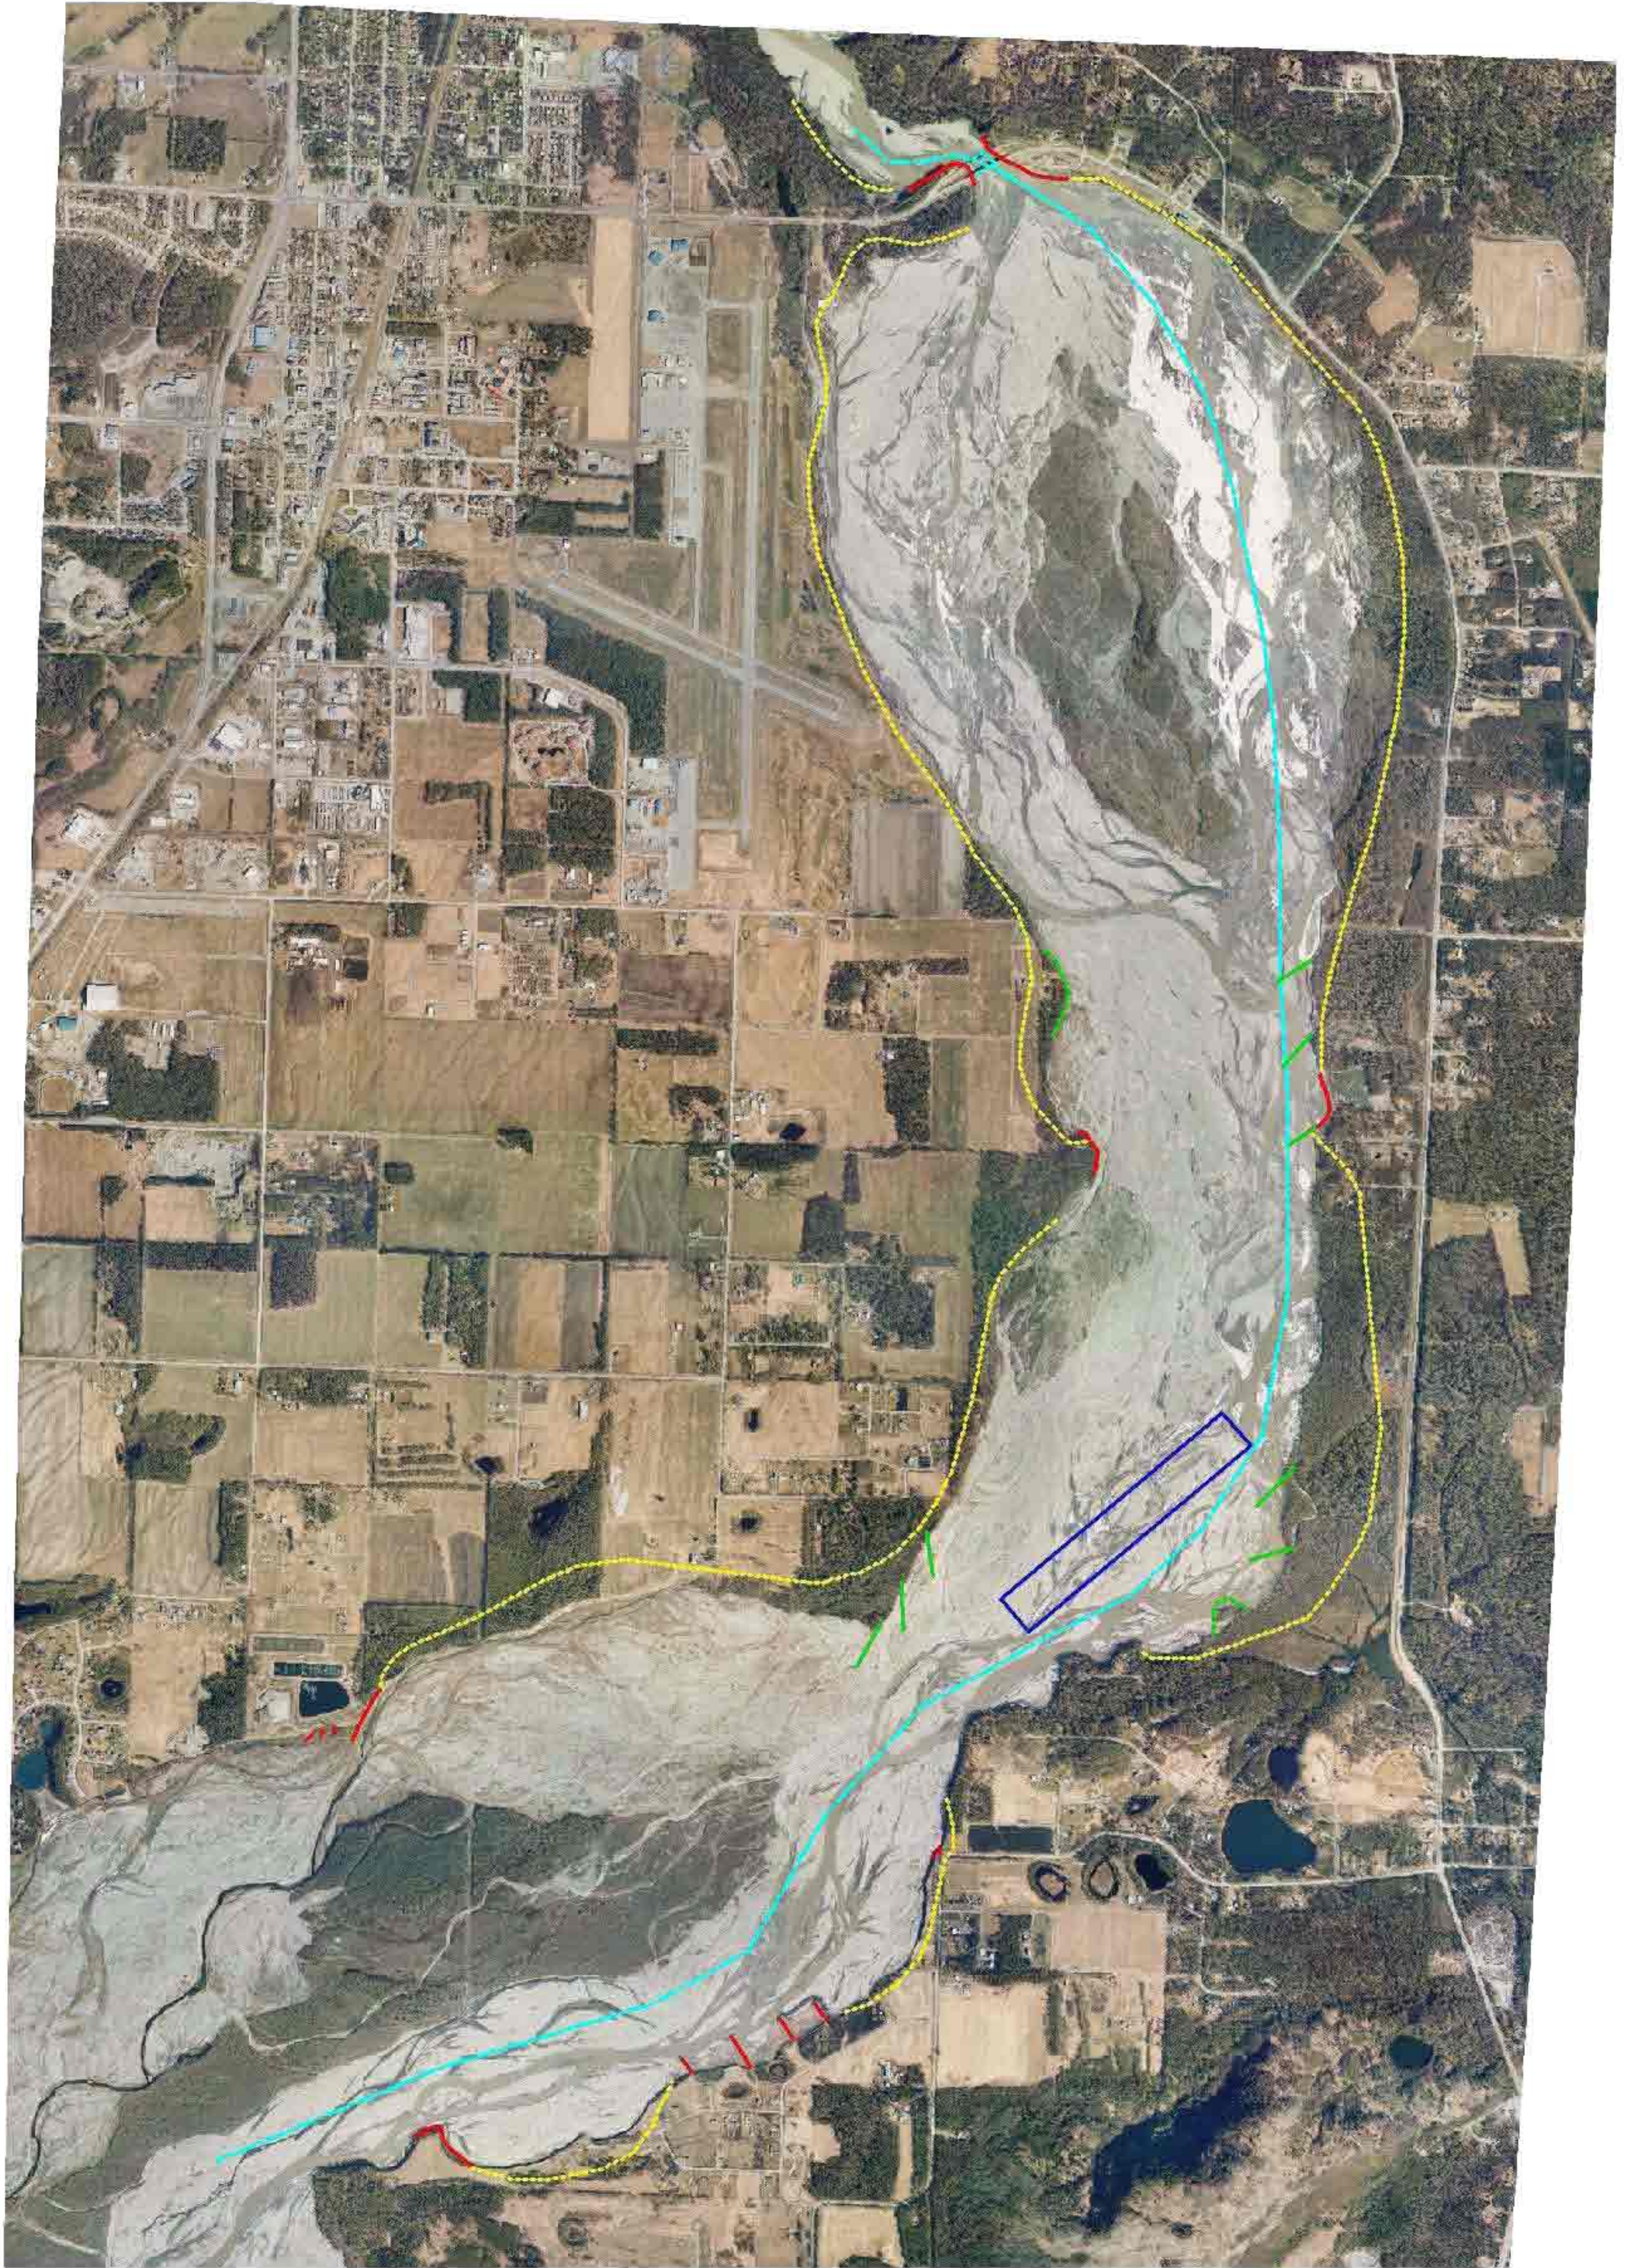
Figure 8  
Option 1 - Gravel Removal

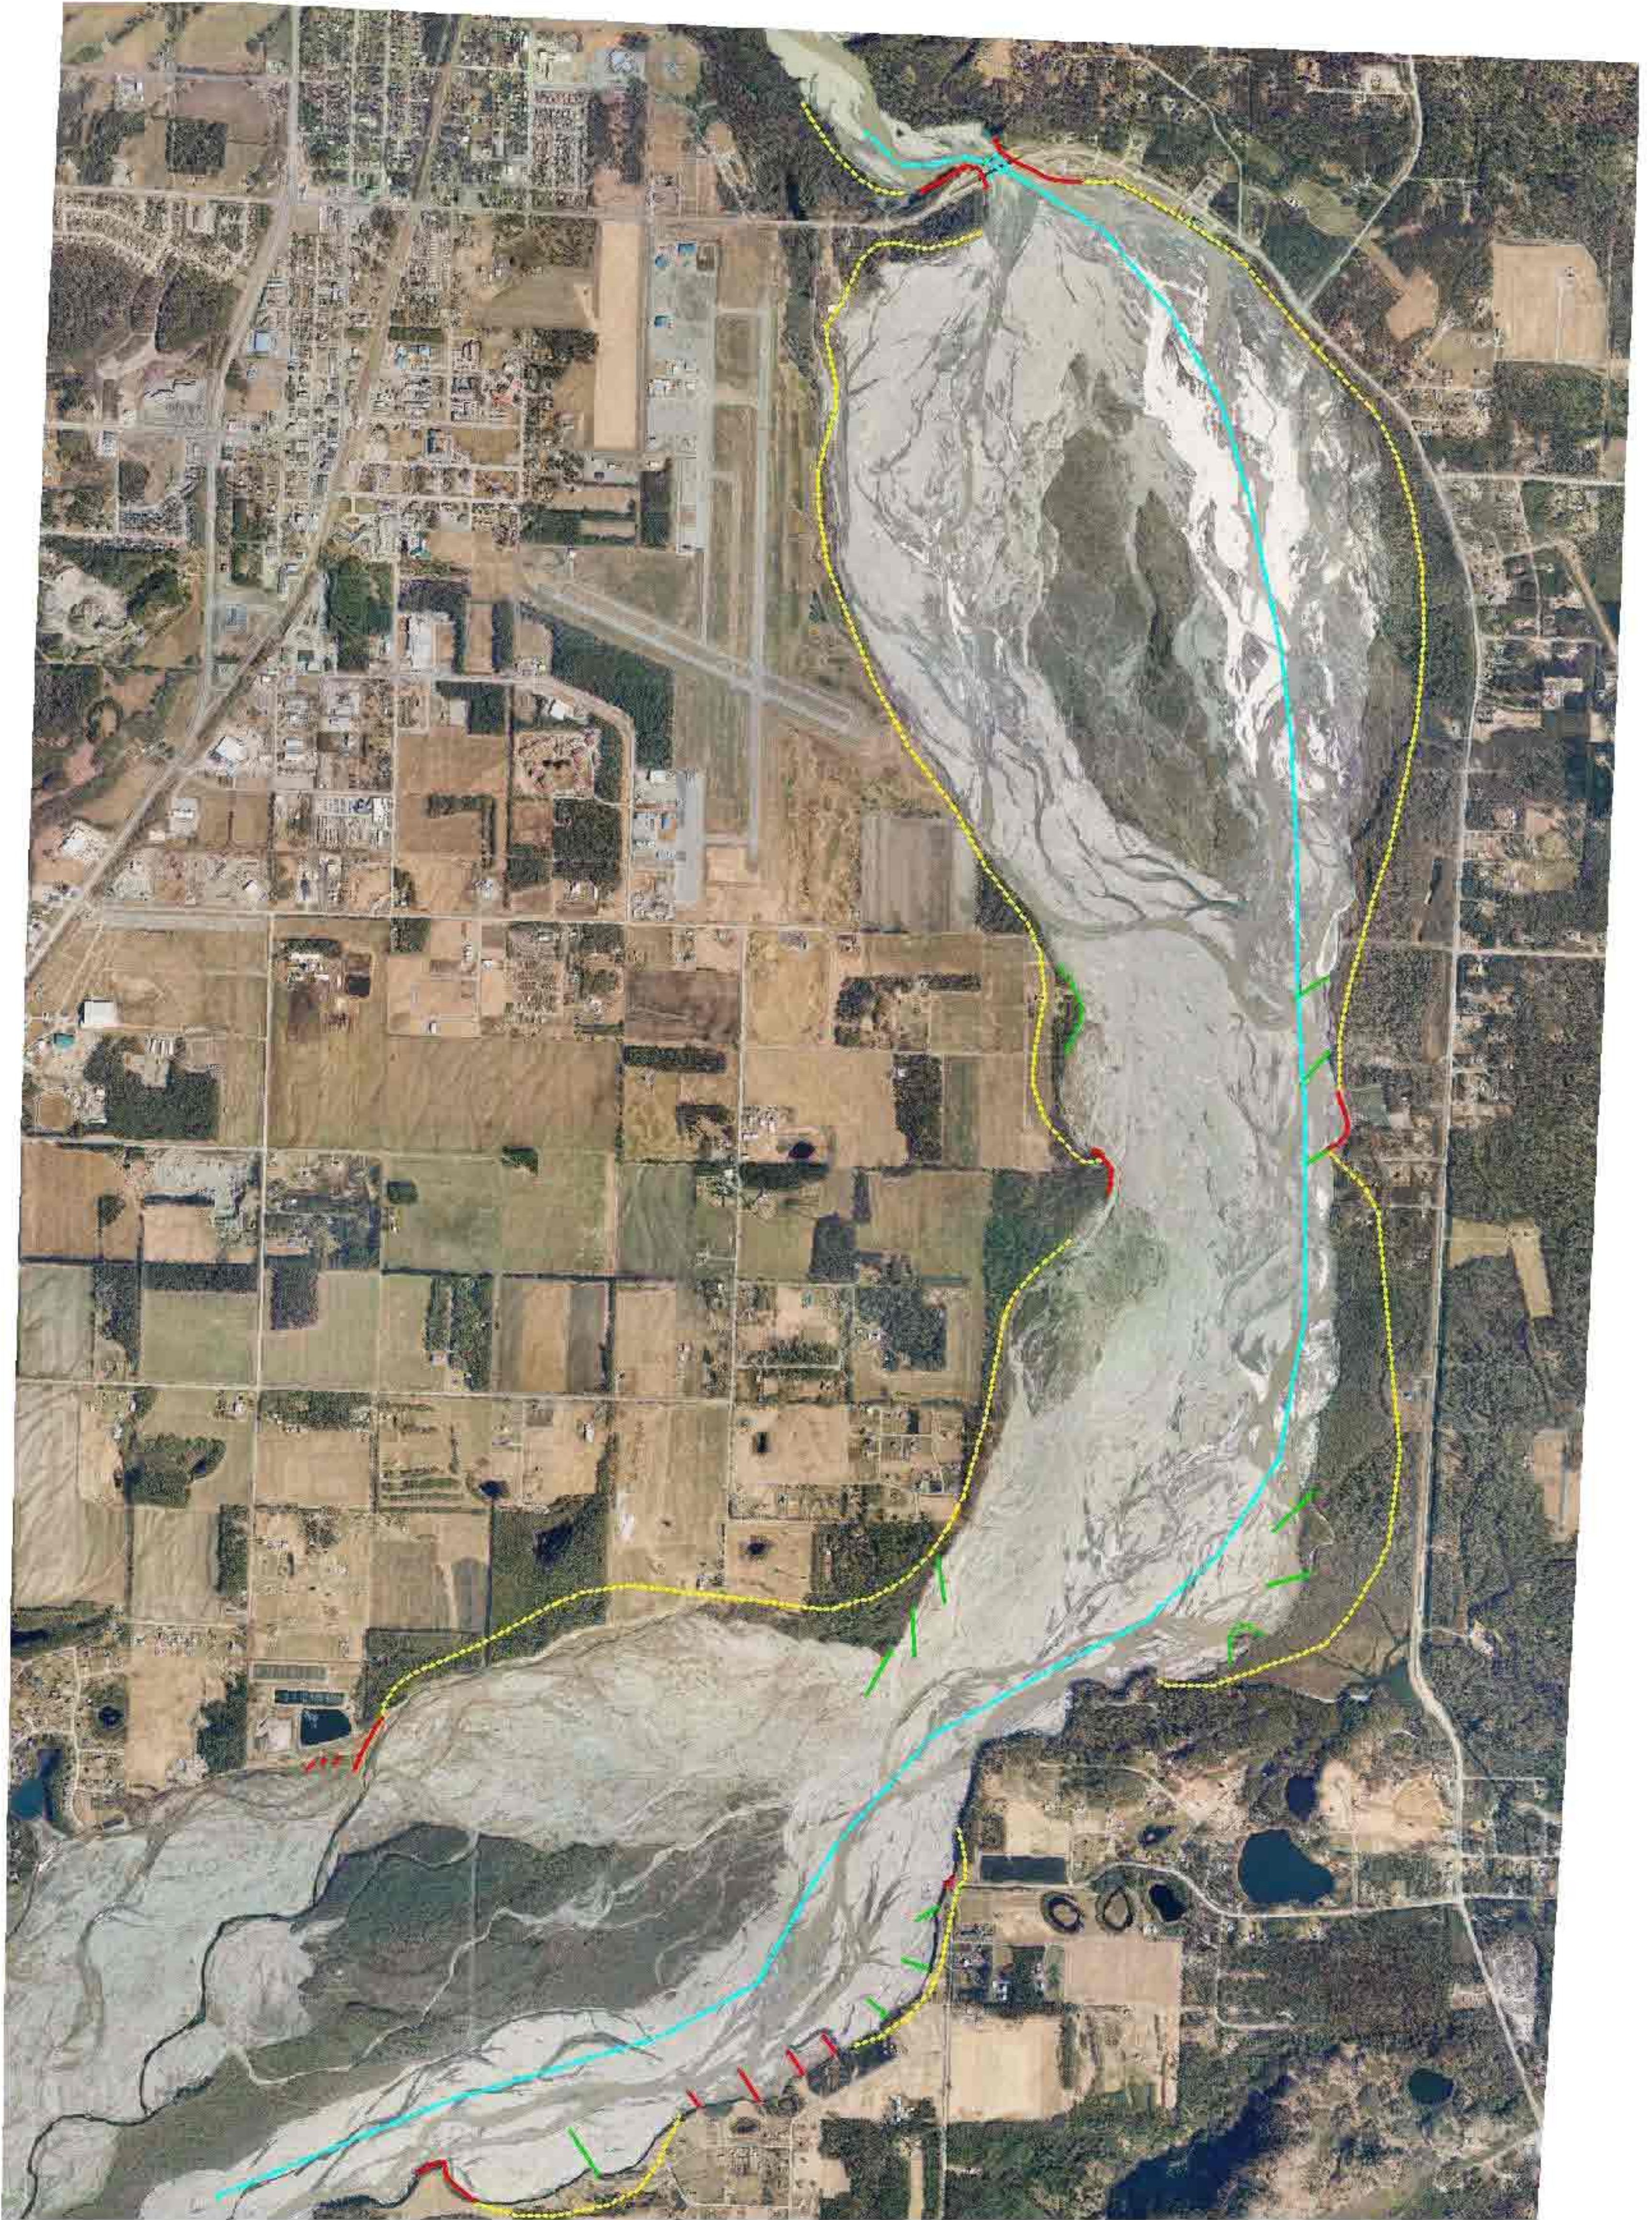
Figure 9  
Option 2 - Gravel Removal and Bank Protection

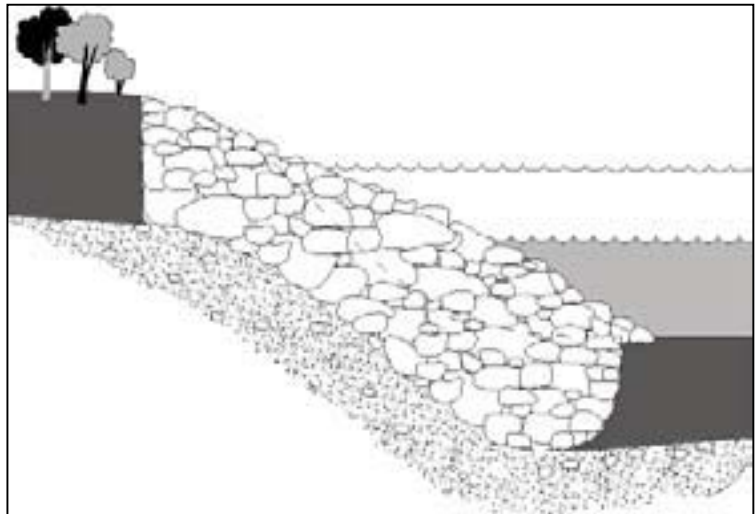
Riprap, grouted or not grouted, is a type of bank armor consisting of rock, typically bedded upon a filter layer of gravel or synthetic filter fabric, with an excavated toe or launchable toe. Historically, riprap has been the most extensively used method for controlling bank erosion in the United States. Recently, however, concerns over the poor aquatic-habitat value of riprap and local and cumulative effects of riprap use on river morphology, have made the application of riprap controversial. For these reasons,

rip rap revetments are recommended only where bank failure would have intolerable consequences, or where site conditions are extreme. Extreme site conditions might include high erodibility, high shear stress, or mass-failure conditions. Grouted riprap can add additional effectiveness; however, costs may be a limiting factor.

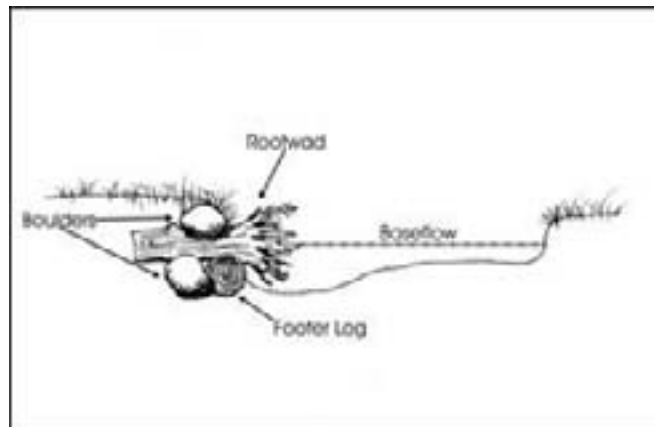
Log toes, also called rootwad, are structural features that prevent erosion at the toe of a streambank. The toe refers to that portion of the streambank that extends from the channel bottom up to the lower limit of vegetation or to a distinct break in slope between the top of the bank and the streambed. Log toes can provide the foundation for nonrock, nonstructural, upper-bank treatments such as reinforced soil or resloped banks. Log toes are generally constructed of logs and gravel fill between logs, but may also include

components made of large woody debris to provide additional habitat value. Log toes may also incorporate rock material to provide added protection. Log toes differ from log cribwalls in two primary ways:
