Matanuska River Management Plan

Adopted: September, 2010

**MATANUSKA-SUSITNA BOROUGH
ORDINANCE SERIAL NO. 10-089**

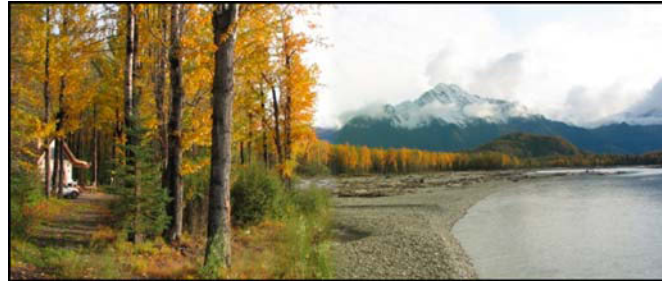
The Matanuska River is eroding the riverbank near Mile 14 Old Glenn Highway threatening area homes. Photo by Scott Easler

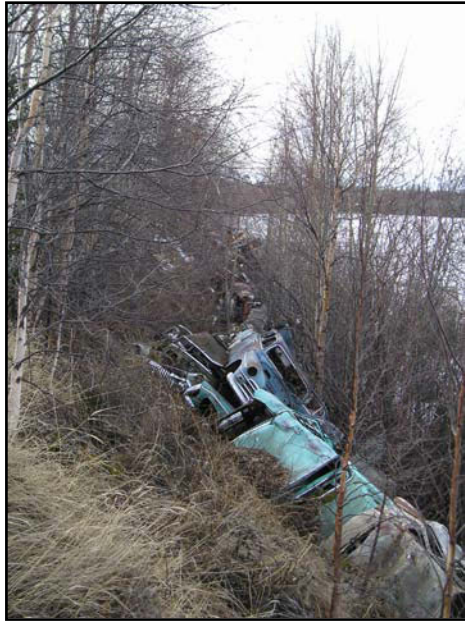
Junk cars have been used unsuccessfully and illegally by private property owners in an attempt to slow erosion along lower reaches of the river.

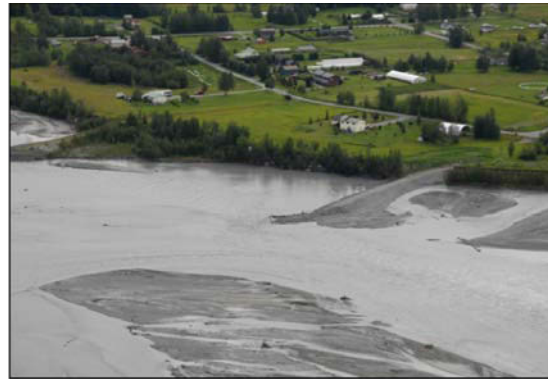
Circle View Subdivision in Butte has a concentration of five finger dikes, like the one shown above, to protect against erosion.

The Circle View and Stampede Estates Flood and Erosion Control Service Area meets quarterly to plan and review river erosion control measures and funds the annual inspection of the five spur dikes to determine if repairs are needed.

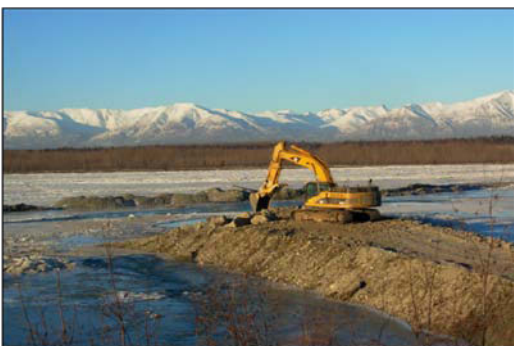
Construction of Dike #5 in Circle View Subdivision.

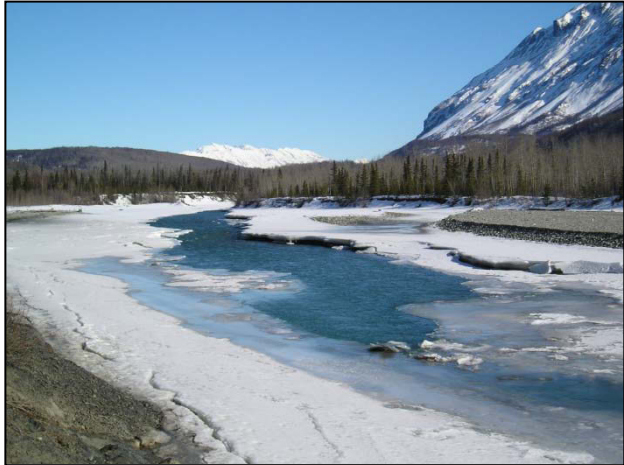
In the Chickaloon area, the Matanuska River is contained by canyon walls and some areas of bedrock, making a narrower, swifter riverbed.

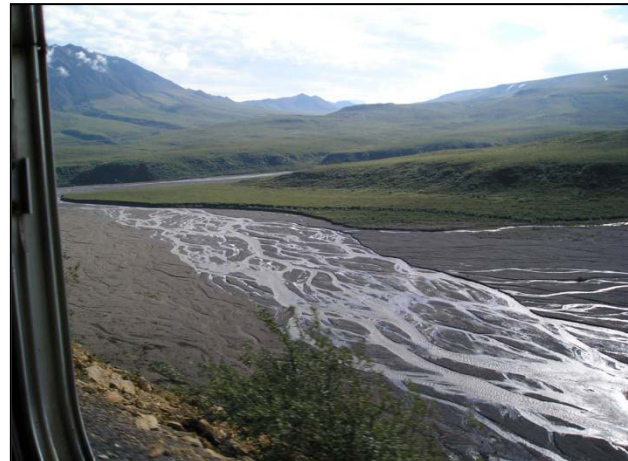
The river corridor near Palmer exhibits the wide, braided characteristics of many glacial rivers.

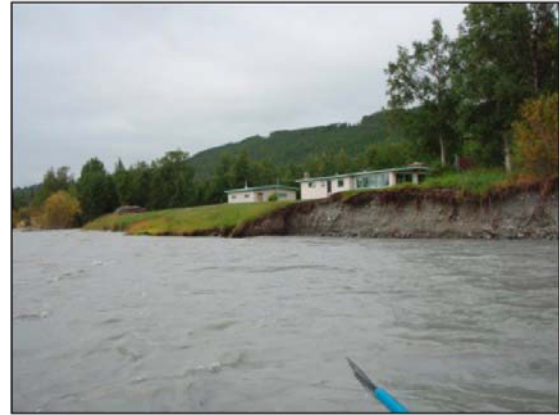
The residents of this Sutton home have taken immaculate care of the property since 1959 as the Matanuska River continues to advance.

Sutton lies along the northern bank of the Matanuska River. Riverine erosion in this area is very active. Channels can shift within an hour and losses have been reported up to 50 feet inland within a 24-hour period. Over the past ten years, near mile 63 of the Glenn Highway, the river has eroded more than 1,000 feet inland. The banks in this area vary widely, from sloping beaches to 200-foot tall cliffs; the taller banks are susceptible to severe and sudden undercutting by the river.

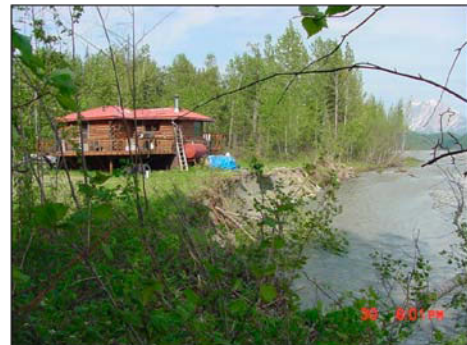
2006 view of one of three homes in Sutton that was included in the Emergency Watershed Protection Program buyout administered by the USDA Natural Resources Conservation Service with MSB Assistance.

- Portions of the Glenn Highway were relocated away from eroding riverbanks (EIP-Sutton).
- 2006 – MSB, USDA and Natural Resources Conservation Service (NRCS), utilizing \$594,000 in funds from the Emergency Watershed Protection Program, administered a buy-out program for homeowners threatened by the river's erosion. Three properties in the Sutton area were successfully acquired through this program. Structures were removed, sites were reclaimed and the properties remain in MSB ownership as river buffer areas not to be developed. MSB and NRCS have requested additional federal funds to continue the project but none have been obtained (NRCS EA).

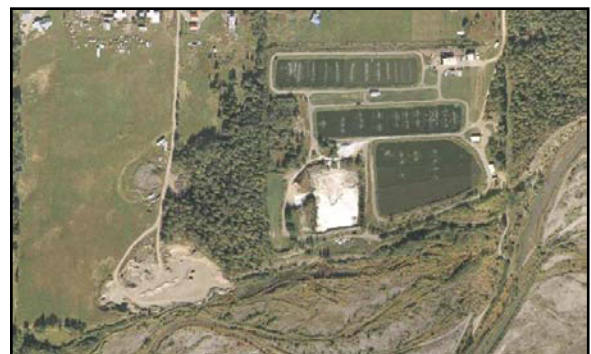
Aerial view of Palmer Wastewater Treatment Plant

On the western side of the Matanuska River lies the City of Palmer and the Palmer Airport. The airport is in relatively close proximity to the Matanuska River, although it does not appear to be in imminent danger from erosion. Farther downriver, but still within the City of Palmer, is the Palmer Wastewater Treatment Plant (WWTP). This treatment plant was threatened by erosion prior to the mid- to late 1980s, when the active channel

was located on the west side of the river. With the exception of the WWTP and a small gravel pit, land use along this area of the bank is typified by residential use.¹

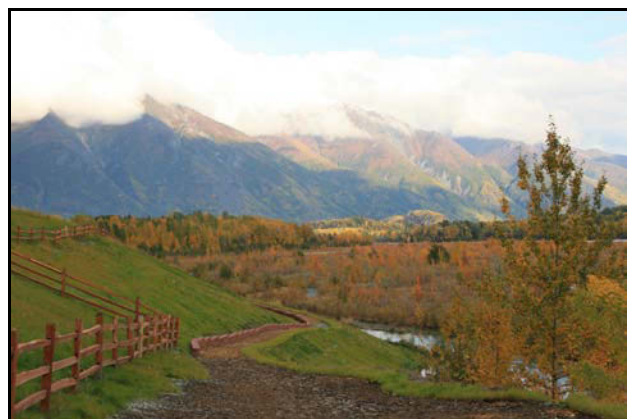
Riverbend Subdivision Trail Photo provided by Kevin Sorenson.

Erosion protection is usually only effective when installed over long stretches of riverbank affected by erosion. Erosion protection installed on small parcels may be ineffective as river forces can easily overpower smaller structures. The example set by developers in the lower reach of the Matanuska River (Riverbend Subdivision) to develop large enough parcels to support structural erosion control installation and maintenance as part of the plat approval action should be analyzed and emulated on all segments of the river. A service area or homeowner's association can be formed to assist with funding maintenance.
